# **Historic Downtown Hobart Building Assessment and Rehabilitation Guide**

**Prepared for the Hobart Redevelopment Commission**

**Dean A. Kessler, Ball State University**

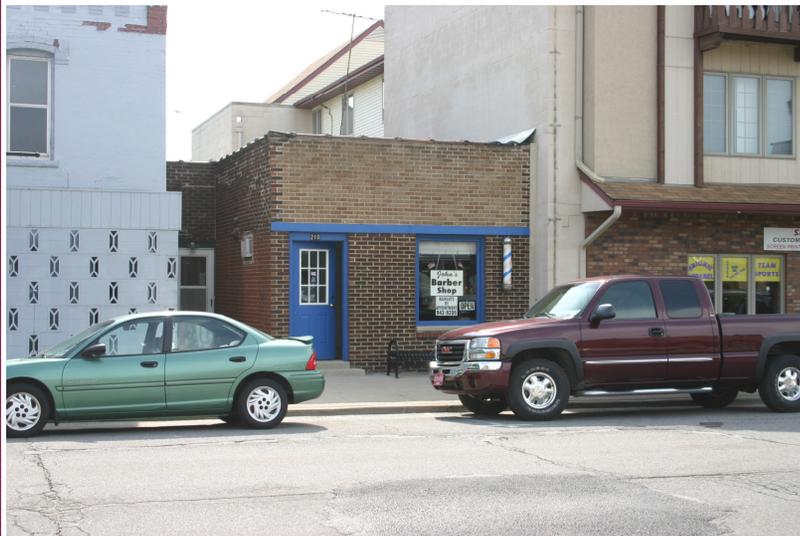
### **210 Main Street:**

The materials consist of the original brick façade on the east and southern sides. A blue, wooden string-course adorns the tops of the door and window. The door, is a replacement, paneled, steel door with a nine-paned window on the upper half. The storefront window is an aluminum replacement. Molded clay tiles line the top of the **parapet** wall. Modern, replacement brick is located between the wooden string-coursing and the top of the parapet wall. Tuck pointing of the mortar was done at the top of

the south façade, but there is cracking of the mortar joints and missing mortar in the same section. The southern façade exhibits replacement brick in two sections that appear to have once been openings. One such closed opening is located below a modern wall-unit air conditioner.

**Suggestions:** Address the cracking and missing mortar on the southern façade caused by settling of the building. Replace the missing and cracking mortar to prevent water infiltration and structural harm. As a general maintenance concern\*, inspect the parapet wall for water infiltration into the masonry walls. Make sure the parapet wall is not disengaging from the main structure of the building. It is also suggested to repaint the door, window, and wooden string-course to a brown or more earth-tone color that would be more appropriate to the age of the building. (\*General maintenance work is not covered under the façade grant program.)

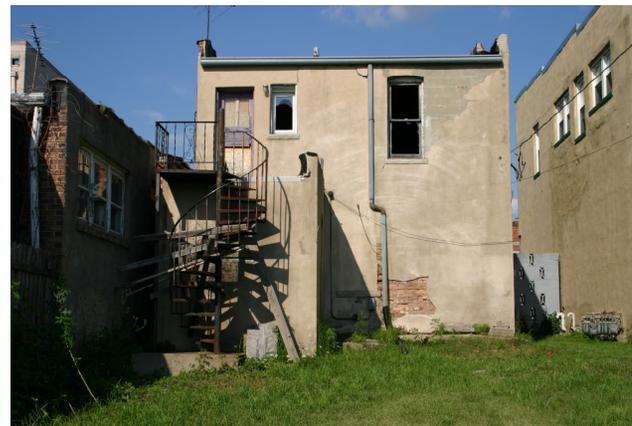
### 214 Main Street:

The two-story, brick building with **Italianate** features uses wood framing and has molded, clay tiles at the tops of the **parapet** wall. A cornice consisting of evenly-spaced, tiered, brick **dentils** lines the top of the parapet wall on the east (front) façade. The east façade has been covered in a blue-grey stucco. Two, replacement, wood, awning windows are located on the first story of the east façade, while three, original window openings have been blocked in with **CMU's** on the first story of the south façade. Five, original, wood, double-hung, one-over-one windows with modern aluminum storm windows are located throughout the second story. All of the windows on the first and second stories have limestone sills. The two, second-story windows on the east façade have decorative brick window hoods, while the rest of the windows throughout the building have only brick arches over them. One, replacement, paneled, steel door is located on the south façade for access to the first floor. One, original, wooden door with large, central **light** and original, wooden transom window above it exists on the east façade and has access to the second-story loft spaces. A modern brick wall was constructed on the east side of the building around the 1960s or 1970s. The mortar in the mortar joints of the parapet wall on the south façade is either missing or cracked. The glass on the second-story windows of the south façade is also missing or severely broken. The outside of the original, wooden door on the east façade is beginning to warp and rot. Patches of stucco have also begun to fall off the face of the building.

**Suggestions:** Remove inappropriate, brick wall from in front of the east and south façades of the building. Stabilize parapet wall by, one, analyzing if there is any water infiltration; two, making sure wall is not disengaging itself from the building; and three, by repairing cracked mortar and replacing missing mortar. Before replacing any of the character-defining, original, wooden, windows, look for estimates on repair and restoration of the sashes, weather stripping, glazing, and the replacement of any missing or broken glass. New, more energy efficient storm windows may be installed over restored, original windows. If possible, do not replace original windows with new, vinyl windows. Vinyl windows will take away from the character of the building and will not last as long as the original windows. Carefully restore original, wooden door and transom by handscraping/sanding chipping paint and then repaint. Replace beyond repair or missing parts with in-kind materials. Gently remove stucco from east façade and clean all brick surfaces using mild detergents, soft scrub brushes, and **LOW PRESSURE** water. **Do not sandblast!** Do not use concrete to patch cracked/missing mortar.

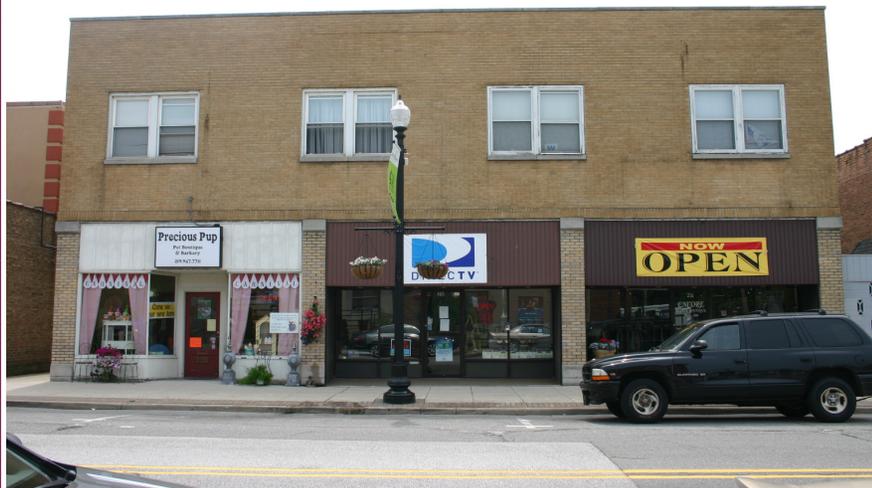
for Indiana Construction Material Company. It sold lumber, paint, and coal along with other building materials. At that same time, Powder Puff Beauty Shoppe was located next door at 218. Hobart Real Estate Exchange was in the last storefront at 220 with Floyd Harrison as the agent. Charles Banker, a contractor and decorator, occupied the space at 216 in the early 1950s. He sold paints, wallpapers, wallpaper steamers, polishers, sanders, etc. 216 and 218 were both Henri's Dress Shop by 1978-79, and 220 was Nawrocki's liquor store. Brickie Photo took over the two storefronts Henri's occupied by 1987, and Friendly Frank's Comics then used 220. The two-story, buff-colored brick Ben Ack Building was built also using wood, concrete, and pressed sheet metal (220 storefront and top of **parapet** walls). 220 retains its four, large, original, aluminum, storefront windows, while 216 and 218 both have four, large, replacement, storefront windows and recessed entry ways. 220's entryway remains flush with the east (front) façade of the building. 220 also retains its original, wooden door. 216 and 218 have one, replacement, aluminum door each.

There is a total of 15 windows on the east and north façades. Four of those windows on the north side of the east façade are original, wood, double-hung, one-over-one windows with modern aluminum storm windows. The other 11 windows are replacement, vinyl, double-hung, one-over-one windows without storm windows.

**Suggestions:** Using a mild detergent, soft scrub brushes, and low water pressure, carefully clean the masonry to remove dirt, soot, and rust stains caused by past signage. Repair or replace any cracked or missing mortar. Do not use concrete as a substitute for a good, lime mortar. Retain the four, original, second-story windows and repair them if need be. Do not replace them. Retain the 220 façade. It is a good example of an original 1920s storefront. Gently clean pressed sheet-metal surfaces when necessary. Handscrape/sand wooden door if paint starts to peel and then repaint. If rehabilitating the storefront façades of 216 and 218, match them to the design and feel of 220. Do not continue with the recessed entries and shorten the sign boards above the entries to also match the sign board at 220. Gooseneck lighting fixtures (as seen at End Zone, Paws, and Cagney's) could be added above the sign boards to give the signage more presence.

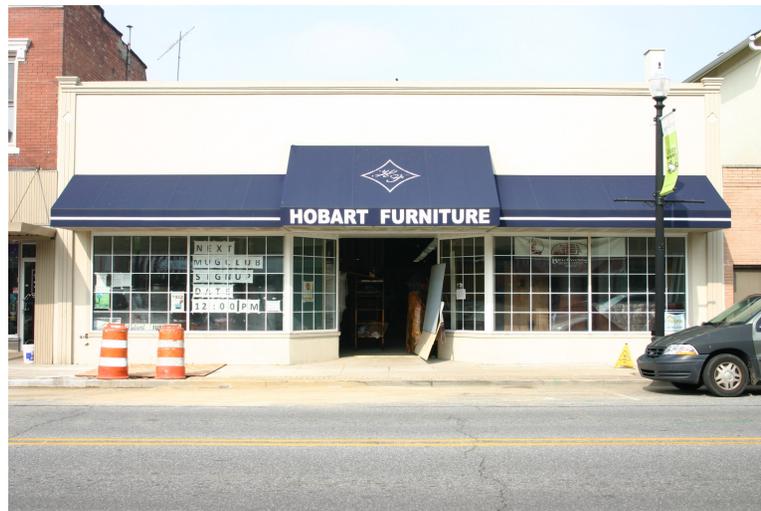
The single-story Ittel Building was originally built in brick by Jacob Ittel in 1940. Its first tenant was a Kroger grocery store — formerly known as Consumers Sanitary Butter and Egg Company (or Consumers Chain). Kroger ended its stay at the Ittel Building in 1960. The property then changed hands to Vossberg's, another grocery store. Later, the building would become Scholl Pharmacy in the 1970s; Joey's Wallpaper in the 1980s; and finally Hobart Furniture. Presently, in 2009, it is being renovated into Brick Works Brewery. The original, brick exterior of the west (front) façade has been covered over in **EIFS**. There are six, large, modern, vinyl, storefront windows divided into several panes each. The doors have been removed for the purpose of completing the renovation.

**Suggestions:** In anticipation of the new business, it would be more appropriate to have the original, brick façade exposed. Carefully remove a portion of the EIFS to check on the condition of the masonry. If the brick is still well intact and can be repaired, remove the rest of the EIFS. While the current awning does not match the name of the new establishment that will be operating there, it is of the correct proportions and design. The shed-roof style of the awning fits the character of the building as well as the downtown district. The color of awning is also appropriate for the age of the downtown and the building. It does not detract from the 1940s feel of the storefront or from the buildings that neighbor it. When selecting a new awning, use the current one as an example. Also, if more signage is to be added, be sure to place it parallel, or flush, with the storefront façade.

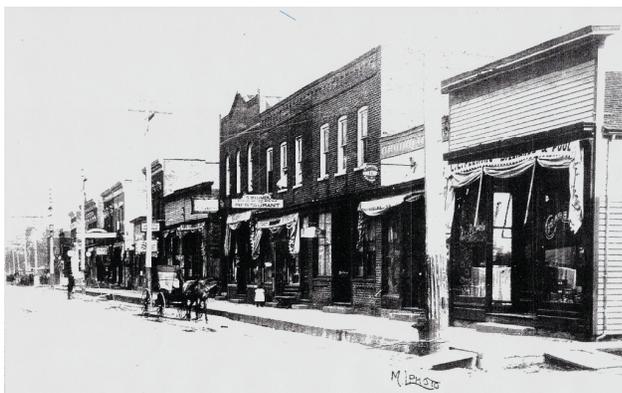
There are two, separate, storefront spaces for O'Dell-Smith Jewelers. Both **Commercial-Vernacular** buildings are brick and a single story. These buildings replaced similar-sized, frame buildings (seen on the very right-hand side of the first photo below) in the late 1950s and early 1960s. The original buildings once housed a harness shop around 1876 and Edgar H. Kleine's pool hall around 1910. The O'Dell-Smith company has been located at this site since 1934. The two, modern, storefronts both contain large, aluminum, storefront windows and modern, aluminum doors with transom windows above them. Aluminum and sheet-metal panels have been added over the original brick on the western (front) façade of 343.

**Suggestions:** Remove the metal panels from the 343 storefront to inspect the condition of the original, brick, façade. If the masonry is in good condition, do not recover the façade. Leave the brick exposed so that it matches the neighboring buildings. If the glazing (faces) of the brick have been damaged or have fallen off, find historically-appropriate material to recover the façade so that structural damage to the wall does not occur. The awning over 347 is an appropriate style for the historic downtown and for the building, but the color does not fit with the historic character of the area. A darker blue, maroon (dark red) or even black could be used on the shed-roof style awning. The **parapet** wall of 347 should also be inspected to make sure that the large signs are not causing it to disengage from the building or cause structural problems. These signs should also be made smaller so that they fit below the top of the parapet wall. They can remain flush

with the building as they currently are. If the masonry needs to be cleaned, use gentle detergents, natural-bristle brushes, and low water pressure. Do not sandblast the brick to clean. This will cause major damage to the brick glazing. If that occurs, water will most likely infiltrate through the wall compromising the structural integrity of that wall.

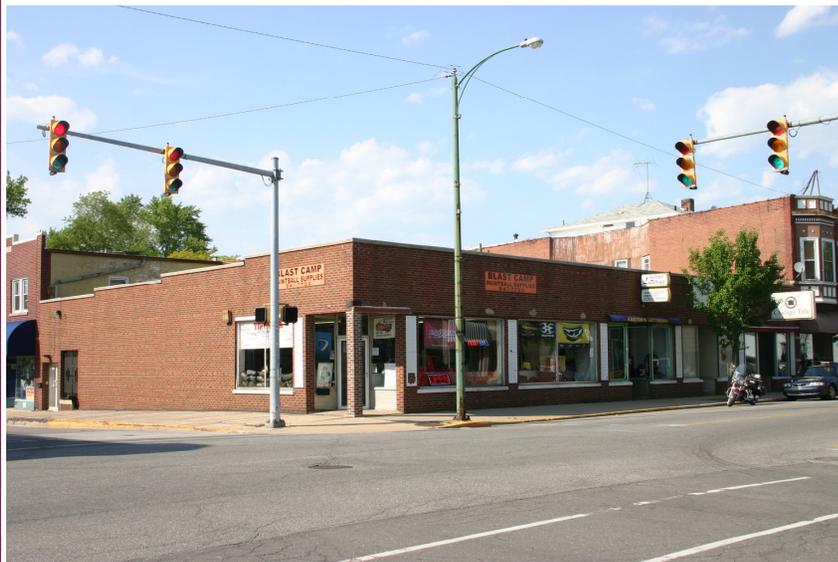
Each of the four, south-facing, storefront façades are different. 600 has six, large, aluminum, storefronts — two on the west façade and four on the south façade. A single, replacement, aluminum door with storm door and transom window above it is located directly on the southwest corner. 604 has a single, replacement, aluminum door with sidelight flanked by four, large, original, aluminum, storefront windows. 608 is the only store front the retails all of its original features. A single, wood, door is flanked by four, large, aluminum, storefront windows. 610 contains a single, replacement, aluminum door with sidelight flanked by four, large, replacement, aluminum, storefront windows. The signage over 600 and 610 is inappropriate. The color of the signs at 600 are not historically accurate, and the hanging sign at 610 is too large. 604’s hanging sign is small enough to not be distracting and inappropriate. Signage flush with the façade would be appropriate and preferred.

**Suggestions:** Remove the rusted grounds from previous signage on the parapet walls of the south façade. Remove the inappropriate and broken vinyl shutters. Carefully remove the chipping/cracking paint on the original, concrete window sills and then repaint. Repair the tile work in the entrances of the storefronts. Change the color and letting of the signage at 600 to be more historically accurate for a 1920s building. The brick should be gently cleaned using mild detergents, natural-bristle scrub brushes, and low pressure water. Do not sandblast the brick as this will take off the glazing/face of the brick and allow for water infiltration into the wall. Make sure to repair any cracked or missing mortar. Do not paint the brick. Also, keep the same configuration of the storefronts. Do not replace original windows or doors. Use shed-roof style awnings over the storefronts. A good color for awnings would be maroon. Gooseneck lighting could be added to highlight signage.
