# **Historic Downtown Hobart Building Assessment and Rehabilitation Guide**

**Prepared for the Hobart Redevelopment Commission**

**Dean A. Kessler, Ball State University**

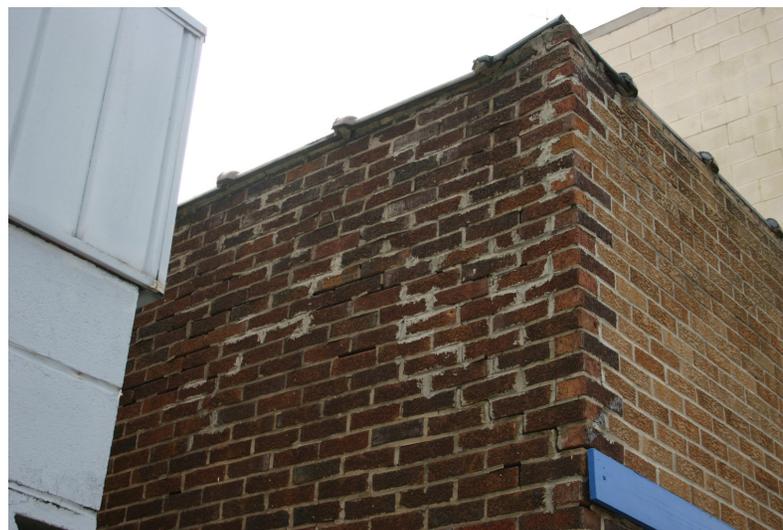
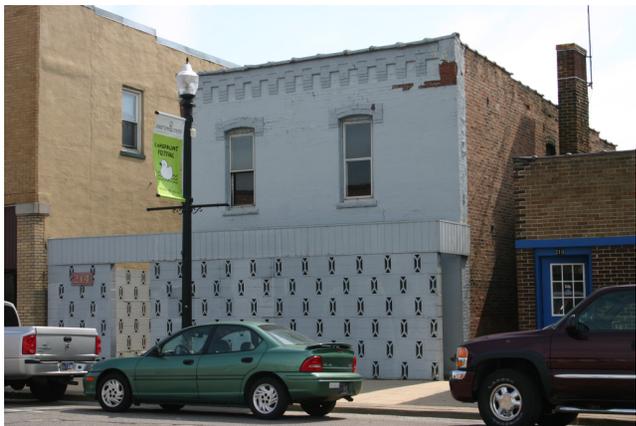
### **210 Main Street:**

The materials consist of the original brick façade on the east and southern sides. A blue, wooden string-course adorns the tops of the door and window. The door, is a replacement, paneled, steel door with a nine-paned window on the upper half. The storefront window is an aluminum replacement. Molded clay tiles line the top of the **parapet** wall. Modern, replacement brick is located between the wooden string-coursing and the top of the parapet wall. Tuck pointing of the mortar was done at the top of

the south façade, but there is cracking of the mortar joints and missing mortar in the same section. The southern façade exhibits replacement brick in two sections that appear to have once been openings. One such closed opening is located below a modern wall-unit air conditioner.

**Suggestions:** Address the cracking and missing mortar on the southern façade caused by settling of the building. Replace the missing and cracking mortar to prevent water infiltration and structural harm. As a general maintenance concern\*, inspect the parapet wall for water infiltration into the masonry walls. Make sure the parapet wall is not disengaging from the main structure of the building. It is also suggested to repaint the door, window, and wooden string-course to a brown or more earth-tone color that would be more appropriate to the age of the building. (\*General maintenance work is not covered under the façade grant program.)

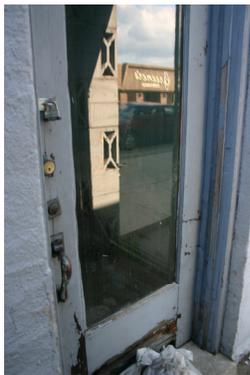
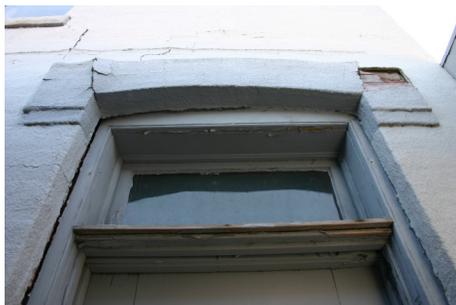
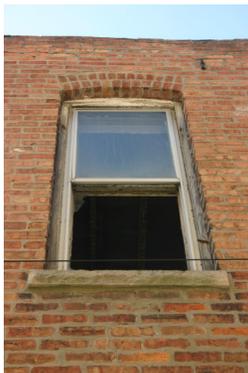
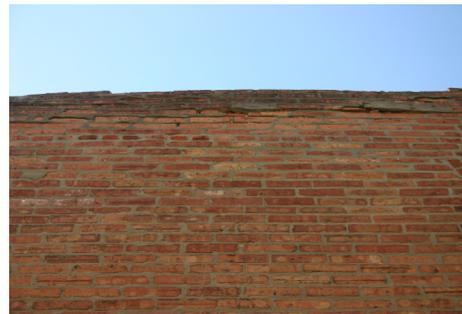
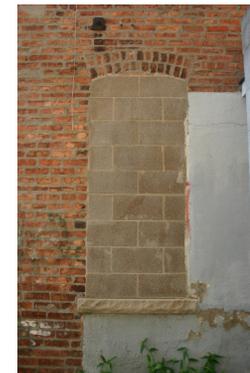
### 214 Main Street:

The two-story, brick building with **Italianate** features uses wood framing and has molded, clay tiles at the tops of the **parapet** wall. A cornice consisting of evenly-spaced, tiered, brick **dentils** lines the top of the parapet wall on the east (front) façade. The east façade has been covered in a blue-grey stucco. Two, replacement, wood, awning windows are located on the first story of the east façade, while three, original window openings have been blocked in with **CMU's** on the first story of the south façade. Five, original, wood, double-hung, one-over-one windows with modern aluminum storm windows are located throughout the second story. All of the windows on the first and second stories have limestone sills. The two, second-story windows on the east façade have decorative brick window hoods, while the rest of the windows throughout the building have only brick arches over them. One, replacement, paneled, steel door is located on the south façade for access to the first floor. One, original, wooden door with large, central **light** and original, wooden transom window above it exists on the east façade and has access to the second-story loft spaces. A modern brick wall was constructed on the east side of the building around the 1960s or 1970s. The mortar in the mortar joints of the parapet wall on the south façade is either missing or cracked. The glass on the second-story windows of the south façade is also missing or severely broken. The outside of the original, wooden door on the east façade is beginning to warp and rot. Patches of stucco have also begun to fall off the face of the building.

**Suggestions:** Remove inappropriate, brick wall from in front of the east and south façades of the building. Stabilize parapet wall by, one, analyzing if there is any water infiltration; two, making sure wall is not disengaging itself from the building; and three, by repairing cracked mortar and replacing missing mortar. Before replacing any of the character-defining, original, wooden, windows, look for estimates on repair and restoration of the sashes, weather stripping, glazing, and the replacement of any missing or broken glass. New, more energy efficient storm windows may be installed over restored, original windows. If possible, do not replace original windows with new, vinyl windows. Vinyl windows will take away from the character of the building and will not last as long as the original windows. Carefully restore original, wooden door and transom by handscraping/sanding chipping paint and then repaint. Replace beyond repair or missing parts with in-kind materials. Gently remove stucco from east façade and clean all brick surfaces using mild detergents, soft scrub brushes, and **LOW PRESSURE** water. **Do not sandblast!** Do not use concrete to patch cracked/missing mortar.

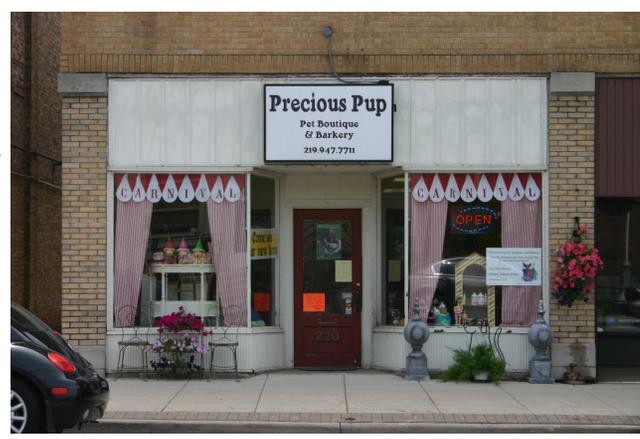
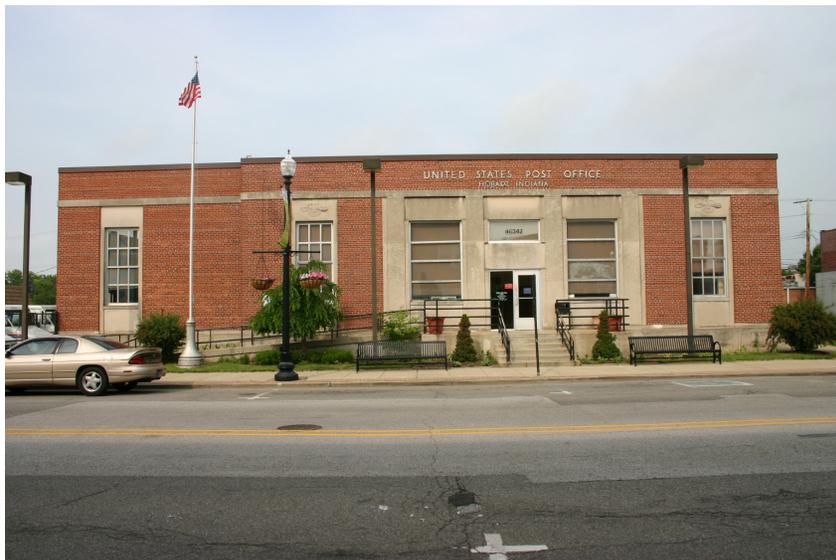
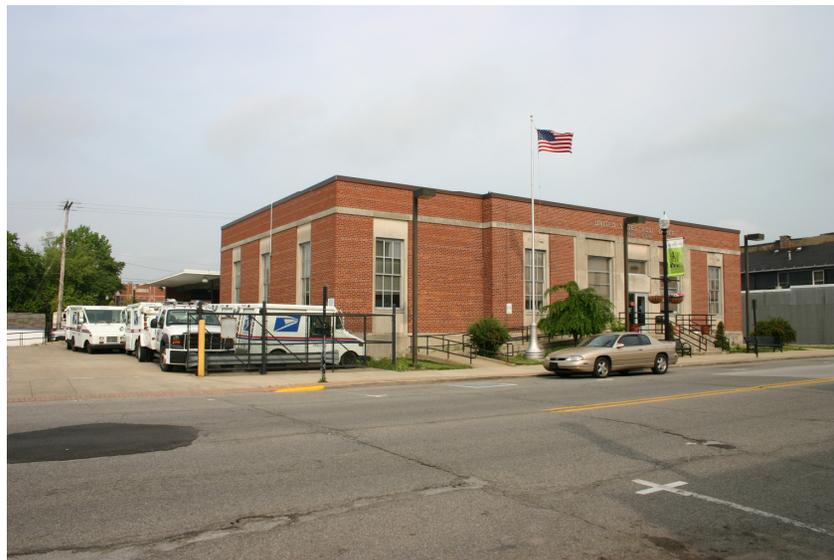
**Ben Ack Building (216-220 Main):** (Elin Christianson, *Hobart Gazette*, and Hobart Historical Society provided historical information)

There is a total of 15 windows on the east and north façades. Four of those windows on the north side of the east façade are original, wood, double-hung, one-over-one windows with modern aluminum storm windows. The other 11 windows are replacement, vinyl, double-hung, one-over-one windows without storm windows.

**Suggestions:** Using a mild detergent, soft scrub brushes, and low water pressure, carefully clean the masonry to remove dirt, soot, and rust stains caused by past signage. Repair or replace any cracked or missing mortar. Do not use concrete as a substitute for a good, lime mortar. Retain the four, original, second-story windows and repair them if need be. Do not replace them. Retain the 220 façade. It is a good example of an original 1920s storefront. Gently clean pressed sheet-metal surfaces when necessary. Handscrape/sand wooden door if paint starts to peel and then repaint. If rehabilitating the storefront façades of 216 and 218, match them to the design and feel of 220. Do not continue with the recessed entries and shorten the sign boards above the entries to also match the sign board at 220. Gooseneck lighting fixtures (as seen at End Zone, Paws, and Cagney's) could be added above the sign boards to give the signage more presence.

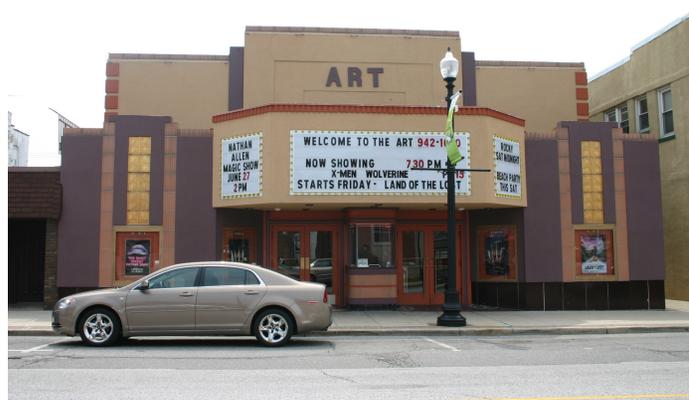
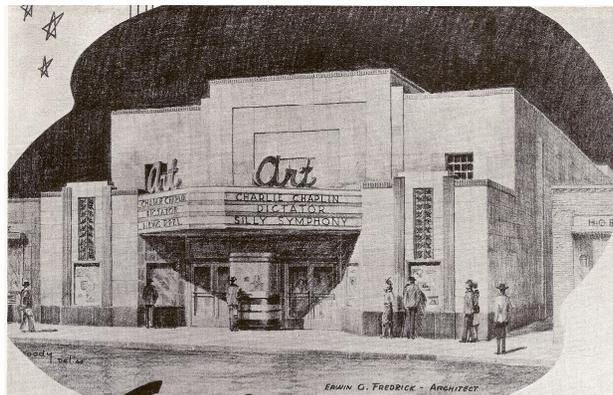
**The Art Theatre (230 Main):** (Elin Christianson, *Hobart Gazette*, and Hobart Historical Society provided historical information)

The Art Theatre was built by brothers Ed and Fred Prusiecki in 1941. Its official opening took place on August 27, 1941. The **Art Deco** building was originally constructed using smooth, glazed, terra cotta tiles on its east façade. Those have since been replaced with **EIFS** when a major rehabilitation was done on the building in 2008. The original, gold, terra cotta insets and reeded columns that flanked the large entryway still exist. Original, marble tiles along the bottom of the east façade are also present. Two sets of original, wooden doors that flank the original ticket booth remain. The southern set of doors contains replacement hardware while the northern set still has the original. The original marquee was removed in 1979 and replaced with a mansard-style roof/marquee. That addition was removed with the rehabilitation and a new marquee, similar to the original, was installed. The four, movie-poster display cases on either side of the entry (2 on the north and 2 on the south) are original as well.

**Suggestions:** Retain and maintain all character-defining features such as the reeded, terra cotta columns; gold, terra cotta, inset tiles; original, wooden doors; marble; original ticket booth; and movie-poster display cases. Removal of any of these architectural elements would be detrimental to the look and feel of the Art Deco style of the movie theater. To unify the look of the entry way, replace the hardware on the southern set of doors (to the left of the ticket booth) with hardware that replicates that of the northern set of doors (to the right of the ticket booth). Repair any cracks or missing pieces in the face of the marble along the bottom of the east façade. Architect pictured below left.

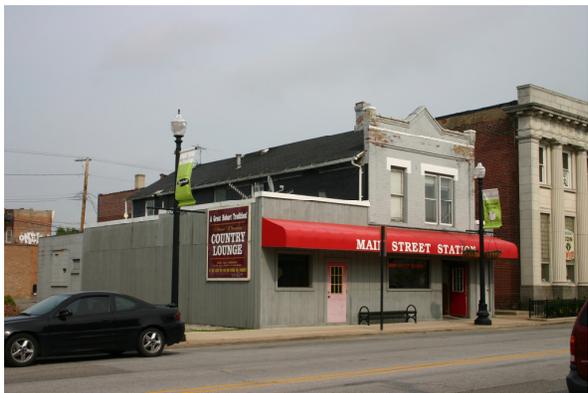
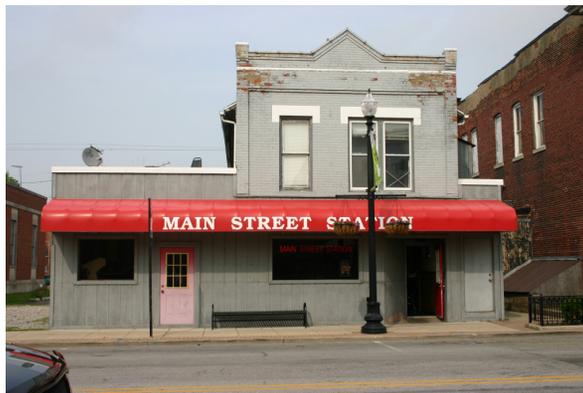
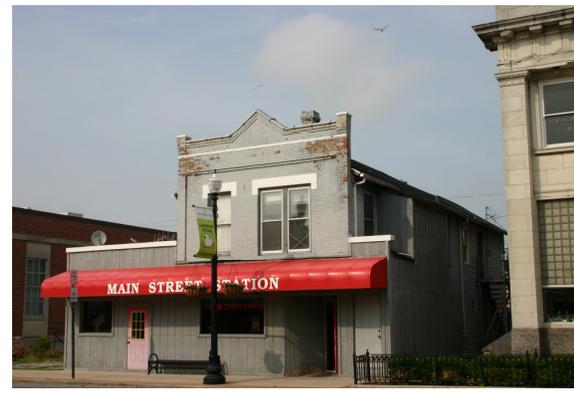
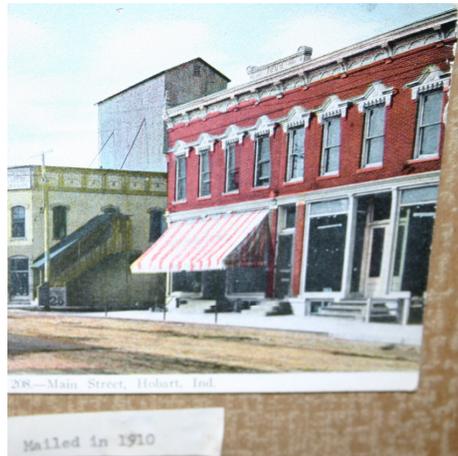
### **235 Main:**

This circa 1890 building was home to Lawrence Traeger along with many saloons and eateries. Traeger lived on the second story while saloons occupied the spaces below. The one-story building to the north has served as lunchrooms and cafés. According to research by Elin Christianson, a selection of the owners of the lunchroom have been Harry Mitchell and his mother; Ruffle Lautzenhizer (from around the 1930s to 1940s according to the 1940-41 City Directory); Kenny and Emma Keilman; and Elmer Kittredge. One of the last lunchrooms, G&E, was run by Eva Theodoras. The building materials currently consist of brick, **CMU**, limestone, wood paneling, and vinyl siding. Based upon the brick exteriors of the second story, it is likely that the west (front) façade of the first story was also made of brick before the wood paneling was installed. Limestone can be found in the lintels over the three, original, wood, double-hung, one-over-one, second-story windows on the west façade. It can also be found in the **belt-coursing** toward the top of the decorative **parapet** wall on the west façade. Molded, clay tiles line the very top of this wall. The first-story window on the single-story, northern portion of the building along with the window located on the first story of the two-story portion are replacements. The six other second-story windows on the auxiliary façades are all vinyl, replacement, double-hung, one-over-one windows. Entrances to the first floor include two, replacement, paneled, steel doors with nine-paned windows on the upper half. Access to the second story is through a replacement, solid, steel door on the southwest corner of the building.

**Suggestions:** Carefully remove portion of wood paneling to see if original, brick façade exists and is in acceptable condition. If so, gently remove all wood paneling. Remove peeling paint by handscraping and clean brick with mild detergents, soft brushes, and low pressure water. If the faces of the brick are damaged or have fallen off, repaint the exterior (to prevent water infiltration) using historically appropriate colors. Be sure to tuck point or replace mortar when needed. Repair and maintain the three original, wood windows on the second story. The awning is a bit inappropriate for the age of building. It could be replaced with a shed-roof style awning that is dark blue, black, maroon, or even a dark green. The current red color is too bright. The lettering can remain the same.

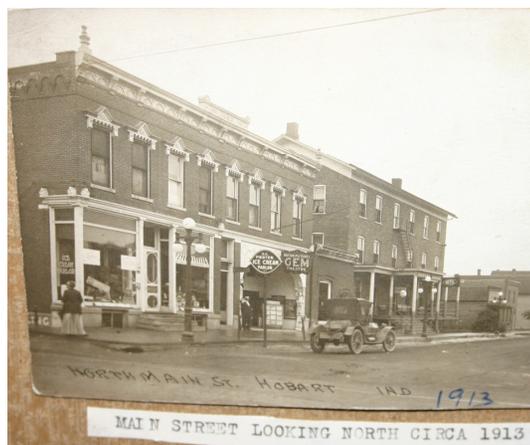
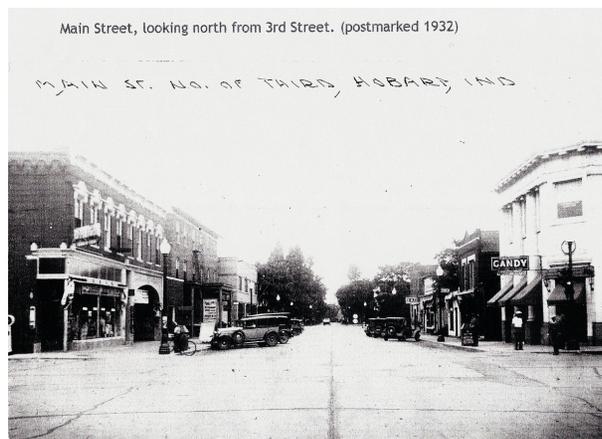
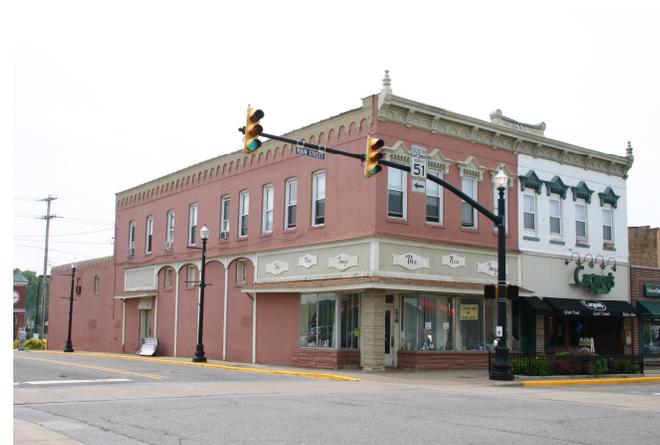
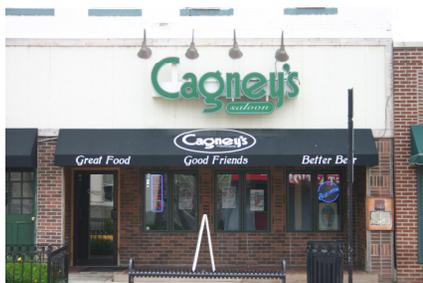
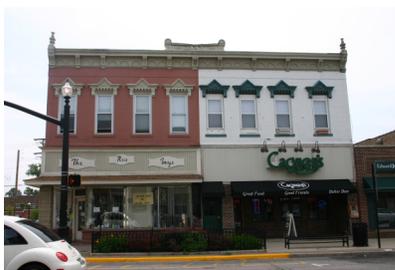
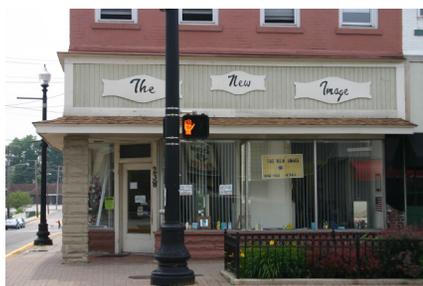
**The Fiester Building ( 236-238 Main):** (Elin Christianson, *Hobart Gazette*, and Hobart Hist. Society provided historical information)

The building has retained its original, brick façades along with the decorative, pressed, sheet-metal **cornice**, **date block**, and **window hoods** on the east façade. Its historic character remains in good condition despite losing the cast iron storefronts and large archway that was placed over a recessed entry at 236 when the theaters occupied the space. All of the original 20+ windows on the second story have been replaced with vinyl, one-over-one, double-hung windows. 236 retains the recessed entry, but has rebuilt the storefront using three pairs of, modern, aluminum,

casement windows and a single, replacement, aluminum door to the south of the windows. 238 retains more of a historic look with its seven, large, replacement, aluminum, storefront windows and a single replacement, wooden door with transom window above it. Both storefront spaces make use of appropriately sized, colored, and lettered sign boards. The gooseneck lighting and awning at 236 is also appropriate and compliments the historic character of the building. Molded, clay tile lines the tops of the **parapet** walls also.

**Suggestions:** Because both north and south storefronts were built at the same time under one ownership, the building should not have two different paint colors dividing the main façade of the building. The paint should be carefully removed by handscraping and washing the brick surfaces with mild detergents and natural bristle brushes. If the paint is protecting the brick due to deterioration of the brick faces, repaint the entire building using historically accurate colors and do not use different colors to differentiate the two sides. If the paint is not being used to protect the masonry, do not repaint. Also, repaint all window hoods the same color—preferably matching the cornice. 238 could also remove the inappropriate addition of the shed-like roof to its first-story façade and replace with an awning that matches in design to 236 for a more unified look. 238 could also add gooseneck lighting to its sign board to match with 236. When replacing windows on the second story of the north façade, replace with windows that fit the original, historic openings like 238 has done. Outdoor seating at 236 would be a great addition to the east façade.

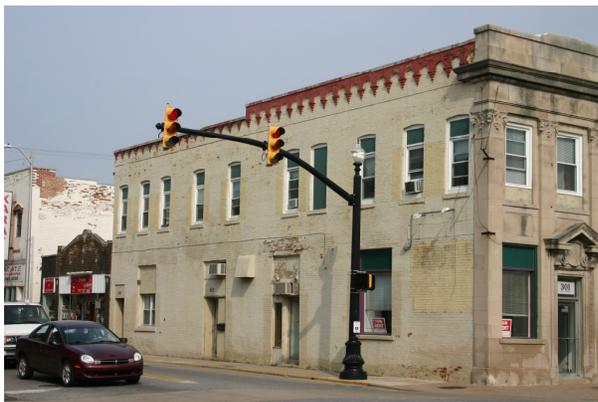
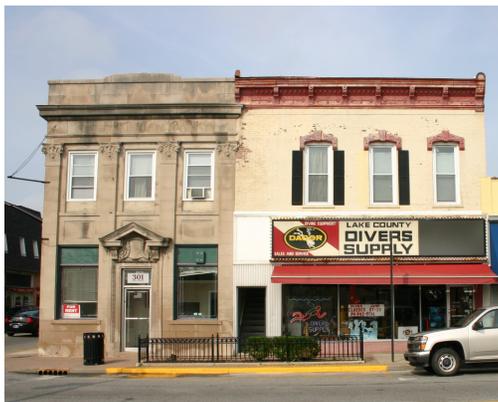
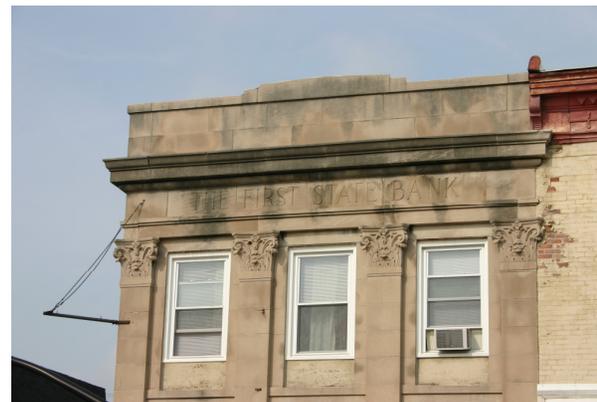
301 retains its Neoclassical façade on the west, while its E 3rd Street addresses (501-505) all bear the original, Italianate façade. The main, western façade consists of a centrally-located, replacement, aluminum door, with transom window above it, flanked by two, replacement, aluminum, storefront windows. The same type of window can be found on the western corner of the north (3rd Street) façade. The entrances to 301-305 are all single, replacement, aluminum, doors.

**First State Bank Continued:** 501 is the only entrance with a sidelight, and the entrance at 505 gives access to the second-story apartments. There are three, replacement, vinyl, double-hung windows on the west façade, and there are nine of the same type of window on the north façade. Ten windows used to exist on the north façade, but one has been removed. The west (front), storefront, façade of 305 consists of a single, replacement, aluminum door to the south with four, large, replacement, aluminum, storefront windows to the north of the doorway. A single, replacement, paneled, steel door is located to the north of this storefront and has access to the second-story apartments. Sheet-metal paneling has been placed around this entrance. Three, replacement, vinyl, double-hung, one-over-one windows are on the west façade of 305. Four of the same type of windows are on the south façade.

**Suggestions:** Two periods of the First State Bank's major, historical significance are well represented currently. The west façade of 301 exhibits the 1920s architecture of financial institutions while the west and south façades of 305 and the north façade of 301 represent the building's original, late nineteenth-century commercial importance. Several things can be done to preserve these historic styles and periods for future generations. A thorough, gentle cleaning of the Neoclassical, limestone façade should be done. The peeling paint on the northern and western façades should be removed by carefully handscraping the brick and then washing it using mild detergents and low pressure water. If the faces (glazing) of the brick are deteriorated or falling off, repaint the masonry using historically appropriate colors. If the brick glazing remains intact, do not repaint. Remove the black shutters on the second-story windows at 305. Carefully remove the faded and peeling paint on the pressed, sheet-metal cornice and window hoods; then repaint. Remove metal paneling around apartment-access door on west façade to see if original brick remains. If brick remains and is in good condition, do not recover. The Diver's Supply sign should be reduced in size; a different font should be chosen; and new colors chosen to make it more historically appropriate. The awning at 305 is of the correct style, but could be made a darker color — dark blues, greens, maroons, or black. If replacing the windows at 301 in the future, find larger windows that will fill the original window openings.

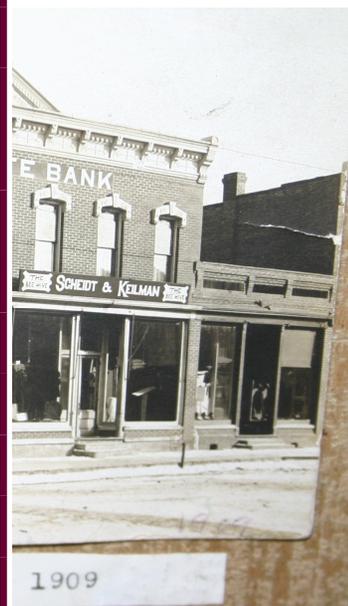
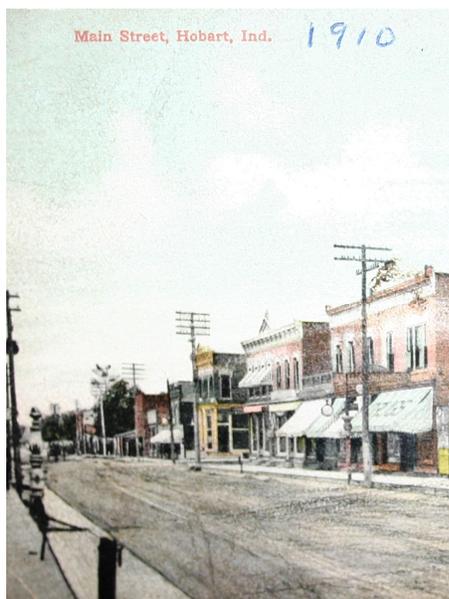
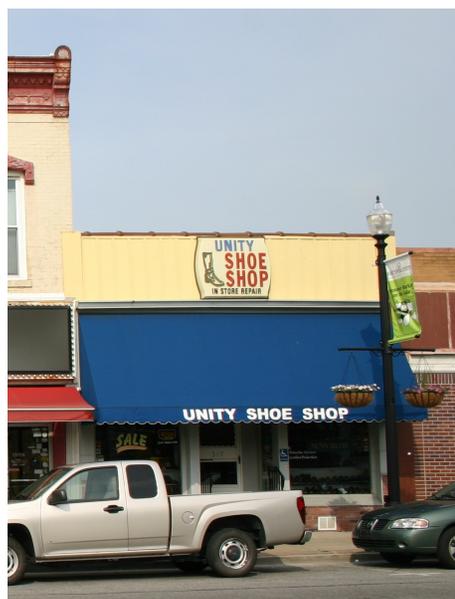
**307 Main:** Unity Shoe Repair Shop (Elin Christianson, *Hobart Gazette*, and Hobart Historical Society provided historical information)

Selling shoes and shoe repair has been in this building from when it was first built around 1880. According to notes by Elin Christianson, president of the Hobart Historical Society, George Stocker was a shoemaker when he first arrived in Hobart, and he started a business in this building. While Stocker was postmaster from 1885-1889, the building served as the post office. Spase Atseff bought the shoe repair shop in 1921 and then bought the building in 1927. Unity Shoe Shop has been located in this building ever since with an Atseff still at the helm. This single-story, brick, building's west (front) storefront consists of a single, centrally-located, replacement, aluminum door with transom window above it. Two small and two large, replacement, aluminum, storefront windows flank the north and south sides of the door. Metal panels cover the brick **parapet** wall. Molded, clay tiles line the top of this parapet wall. A large awning on the west façade is reminiscent of the large awning that appears in the view of the building from the 1910 postcard below. The building can also be seen to the right of the First State Bank Building in the bottom, left-hand photo. The configuration of the storefront remains the same as it has for 100+ years.

**Suggestions:** Remove metal panels from the parapet wall to expose the original brick. Repair/rebuild the parapet wall if the panels have damaged the masonry. Do not remove the molded, clay tiles on top of the parapet walls. The modern sign on the parapet wall is of an appropriate size and placement for the building. It should also remain flush/parallel with the west (front) façade. The configuration of the storefront windows and door should also remain the same because it reflects the original look and feel of the of the late 1800, early 1900 storefront.

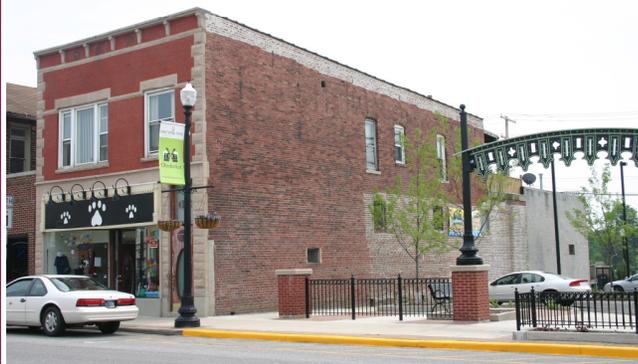
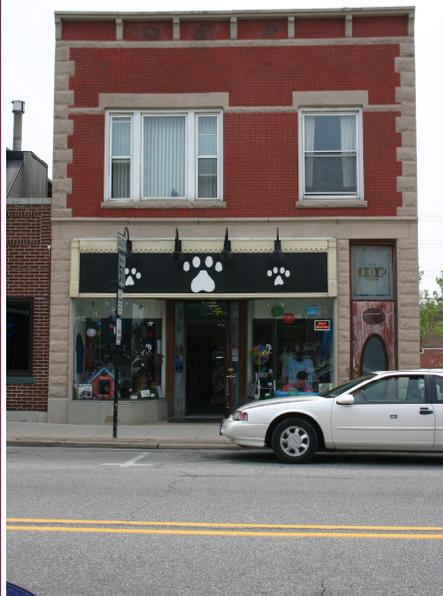
### **The Fiester Building (308-310 Main):**

This building has been well maintained over the years. Its original configuration of the storefront and second-story windows on its east (front) façade remains the same. Today, the storefront consists of a centrally-located, replacement, wooden door with transom above and flanking sidelights. One replacement, aluminum, storefront window is located to the north and south of the doorway. A single, replacement, wood door with large transom window above it allows access to the second story, north of the storefront. The second-story windows are replacement, vinyl windows with modern, aluminum storm windows over them, but remain the same style as the original windows. An appropriately sized and designed sign board with gooseneck lighting has been added over the storefront. It does not detract from the building's historic character.

**Suggestions:** Keep the storefront and second-story window configuration as is. The second-story access door could be handscraped, sanded, and then repainted. If necessary, clean the brick and limestone using mild detergents, natural bristle brushes, and low-pressure water. Be sure to check and make sure that the glazing (brick faces) on the north façade are still intact—especially since the removal of the Strattan Building. If the brick faces are damaged, falling off, or deteriorating, paint could be added to the façade to prevent water infiltration. Choose a historically-accurate paint color if doing so.

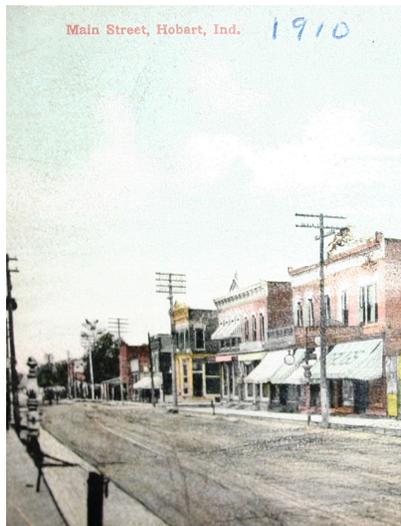
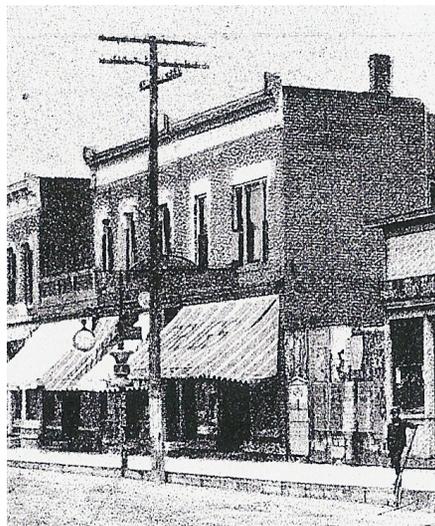
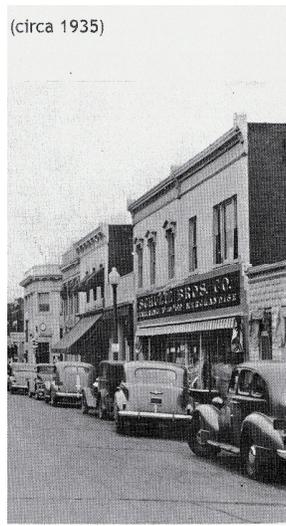
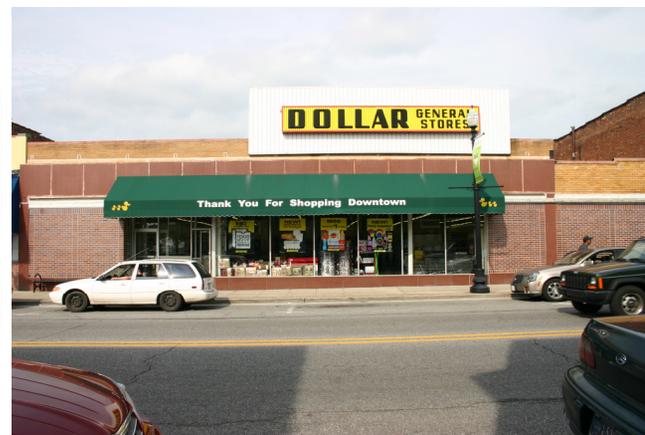
**313 Main:** (Elin Christianson, *Hobart Gazette*, and Hobart Historical Society provided historical information)

This one-story brick, concrete, and marble building was once two stories, as seen in the photos below. The two-stories once held Hobart town offices, for a time, in the second-story spaces. The storefronts were home to Murray's Saloon, Scheddell's Drug Store, and later a furniture store. The Shultz brothers removed the second story and remodeled the building in 1951. The current storefront consists of eight, large, replacement, aluminum, storefront windows and two, replacement, aluminum doors with transom windows above them.

**Suggestions:** The signage for Dollar General on the west (front) façade is too large for the building and is an inappropriate, yellow color. The sign could be made smaller and lowered below the parapet wall. The yellow color is most likely the trademark for the company, but an attempt should be made to discover if permission could be given to design a sign that does not have such a bright background. The awning is of an appropriate, shed-roof-like design and is not too large for the west façade. It could be cleaned to rid it of the deposits left behind from water running off of it. If the exterior masonry needs to be cleaned, do so using mild detergents, natural-bristle scrub brushes, and low water pressure. Do not sandblast or power wash the masonry. This will ruin the glazing/faces of the masonry.

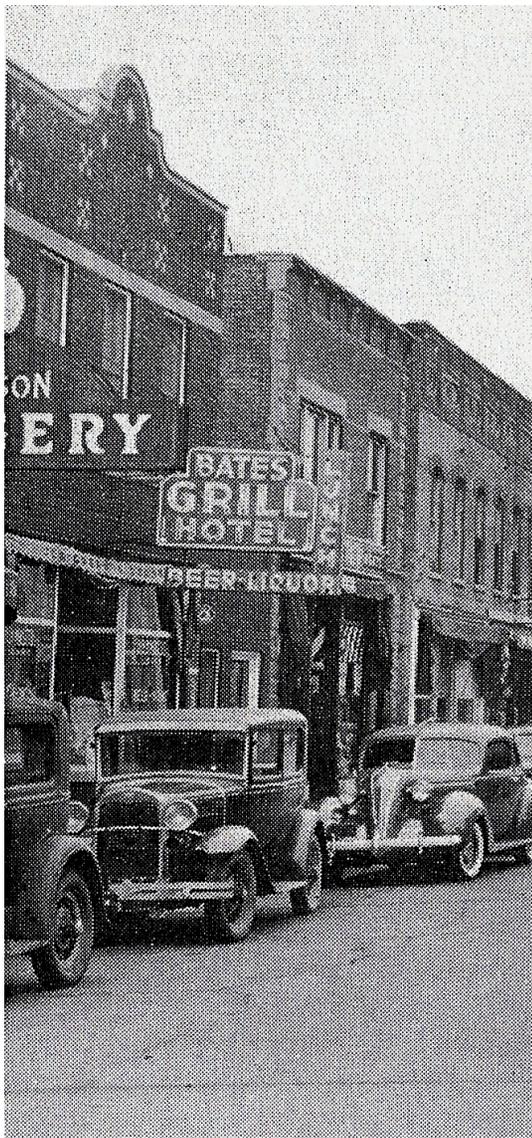
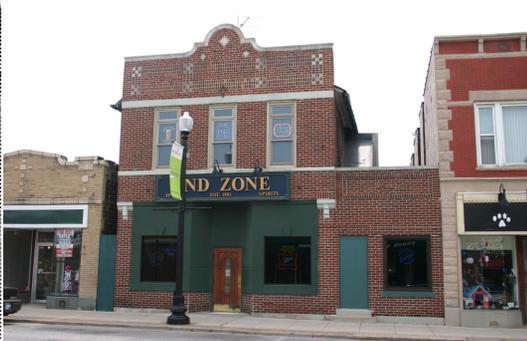
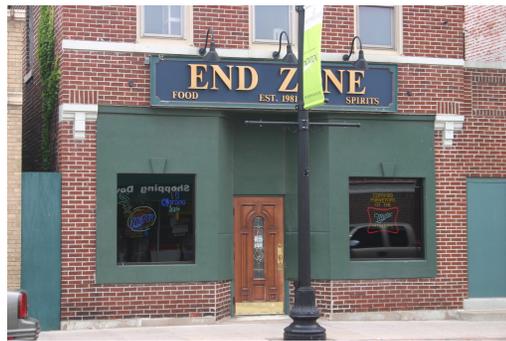
**Orcutt Building (314 Main):** (Elin Christianson, *Hobart Gazette*, and Hobart Historical Society provided historical information)

The Orcutt Building was built in 1912 by Albert Orcutt in place of a two-story, frame building that his father-in-law had once owned. Orcutt opened Bates Hotel & Grill upon completion of the building. In 1930, Orcutt lowered the first floor to the street level. Before that time, the old, wooden sidewalks were about two to three feet above the ground. The building remains in excellent condition today. The east façade's storefront windows have been reduced in size, and the door at the main entrance has been replaced with a modern, wood door. The left-over spaces once taken up by the original, storefront windows have been filled with a material called **EIFS**. The three, original windows on the second story of the east façade have been replaced with vinyl, double-hung, one-over-one windows with transom windows above them. The poured-concrete belt-coursing directly above and below these windows appears to be in good condition, along with the poured concrete insets and molding of the **parapet** wall. The sign board and gooseneck lighting above the storefront is a perfect fit for the building. It adds to the historic character and does not detract attention away from the other architectural features.

**Suggestions:** Reopen the main, east, storefront windows to more of their original size. The storefront feels closed-off to the street. A transom window over the door would also be a good addition that would help tie together new, larger, storefront windows. Carefully clean the masonry and poured-concrete, decorative features using a gentle detergent, natural-bristle brushes, and low water pressure. Do not sand blast the exterior surfaces to clean them. Sand blasting them will

damage the glazing/face of the brick and cause water infiltration. Water infiltration will lead to the weakening of the structural integrity of the wall.

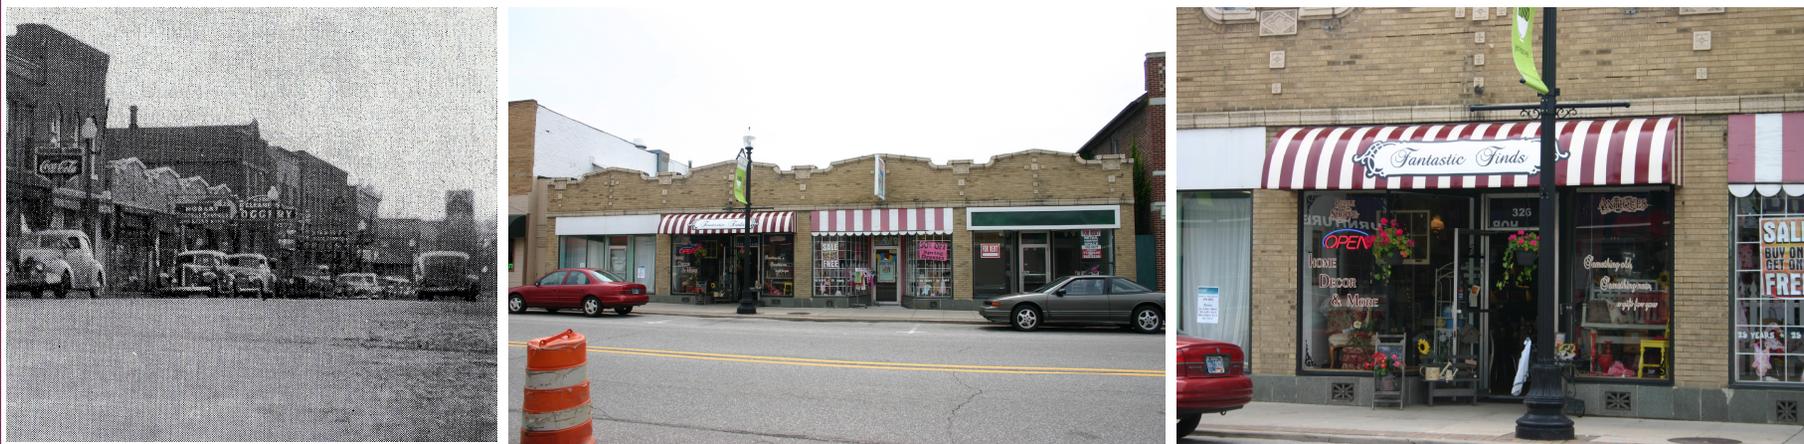
**Verplank Building (318-328 Main):** (Elin Christianson, *Hobart Gazette*, and Hobart Historical Society provided historical information)

The building retains much of its original features on its east (front) façade, such as the large, storefront windows. The doorways in the storefronts have been replaced with modern, aluminum doors with transom windows above them. The terra cotta tiles and inlays above the storefronts and on the parapet wall are in good condition. The marble, tile, banding along the sidewalk is in fair condition, but should be easily repaired.

**Suggestions:** Maintain the storefronts as they are. Do not replace the original windows or change the configuration of the storefronts. Repair the cracked marble along the sidewalk and replace any missing pieces. Give the masonry and terra cotta storefront façade a thorough cleaning using mild detergents, natural-bristle brushes, and low water pressure. Do not sand blast the brick. Sand blasting will damage the glazing/faces of the brick and cause water infiltration, which would be detrimental to the structural integrity of the exterior wall. As a rule of general maintenance, make sure that water is not infiltrating the parapet wall through faulty seals or from the building naturally settling. The signboard above 318 is of an appropriate size and color and should remain similar if not the same. The signboard above 322 should be changed to follow 318's example. The awning at 326 is of an appropriate size and shape, but the stripes detract from the storefront. It could be a solid, maroon color instead. The establishment's name at 326 is printed well.

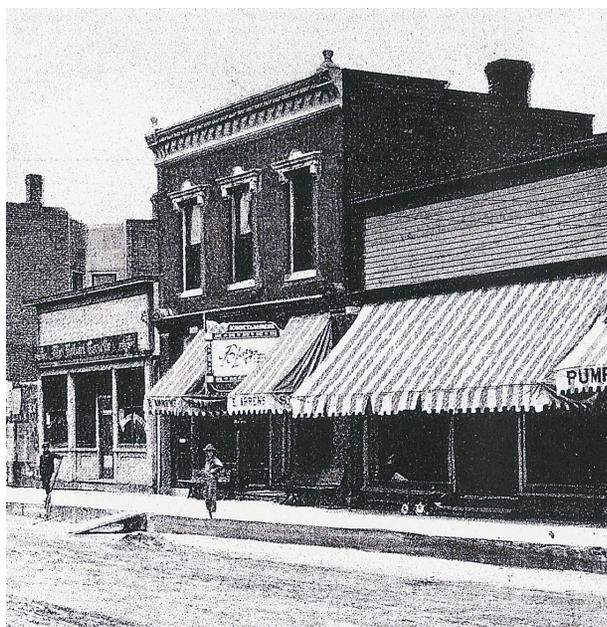
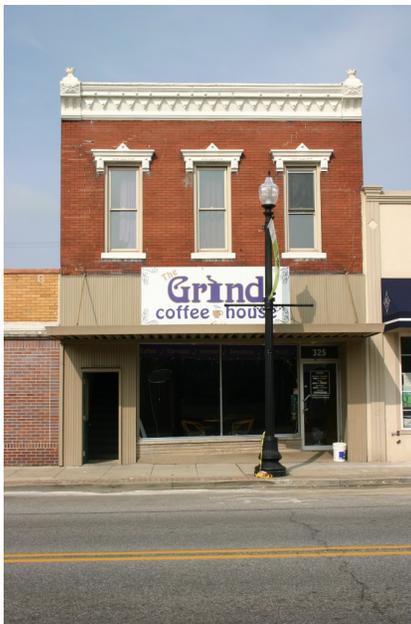
**Watson Building (235 Main):** (Elin Christianson, *Hobart Gazette*, and Hobart Historical Society provided historical information)

Today, the west, storefront façade consists of two, large, replacement, aluminum storefront windows flanked by single, replacement doors — one to the north and one to the south. The first floor has been covered over in sheet-metal paneling. The second-story, brick façade and pressed, sheet-metal **window hoods** and **cornice** remain

in good condition. Three, replacement, vinyl, one-over-one, double-hung windows are on the western, second-story façade as well.

**Suggestions:** Carefully remove the pressed, sheet-metal paneling from the storefront to see if the original brick façade is still underneath and in good condition. Once exposed, make repairs, such as tuck pointing, if needed. The flat roof over the storefront should also be removed because it is not a historically accurate feature, and it detracts from the character of the building. The current sign is also too large and should be made smaller. The color of the text should be changed to a color that is more historically appropriate. Maintain the original window hoods and cornice. Do not remove these features! The masonry can be cleaned using mild detergents, natural-bristle brushes, and low water pressure. As a rule of general maintenance, check the condition of the **parapet** wall to make sure that water is not infiltrating to the interior of the exterior wall. Also, be sure to investigate that the parapet wall is not disengaging itself from the main portion of the building. Disengaging could be caused by natural settlement or water damage.

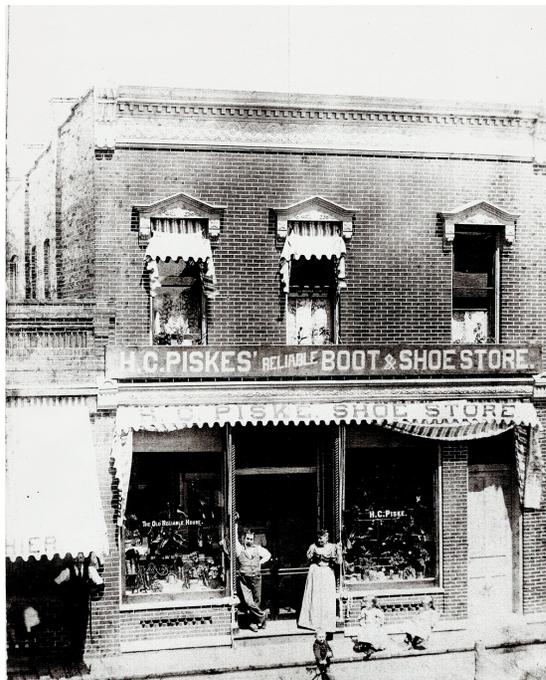
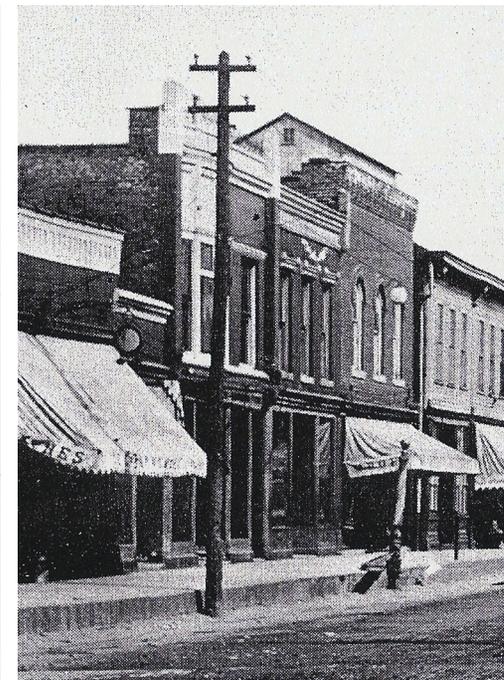
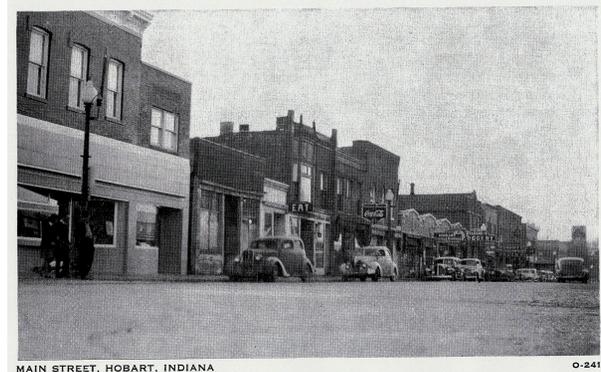
### **Gordon/Manteuffel and Reissig Buildings** **(332-340 Main):**

Much of the original, architectural features of all three buildings have been lost or covered up over the years — such as the cast-iron storefronts and original, second-story windows. The east (front), storefront, façades have all been reconfigured and covered in horizontal and vertical wood siding. Newer, large, replacement, aluminum windows have been placed throughout the new storefront spaces. The second-story windows at the old shoe store building have changed in size, shape, and number. Instead of three windows, there are only two, small, replacement, vinyl, one-over-one, double-hung windows. The original **cornice** still exists at the top of the **parapet** wall. The building to the north replaced its three, original windows with six, similar windows. The building to the south of the old shoe store has kept the window size about the same, but those too are replacements. The north window was replaced with a 20-paned window made of various colors of glass. The original brick has been covered in wood shingles and a stone veneer. There has also been

**332-340 Continued:** addition of new roofs over the windows. All of these changes are inappropriate and have almost made these historic buildings unrecognizable.

**Suggestions:** Remove the all of the materials that have been added over the original brick façades — wood paneling, stone veneer, and wood shingles. Assess the condition of the brick walls. If the masonry is damaged or missing, replace or rebuild the walls. Be observant as to whether the glazing/faces of the brick are in good condition. If the brick faces are damaged or deteriorated, repair them or find another material that would be more historically accurate for the storefronts. Clean the brick facades using gentle detergents, natural-bristle scrub brushes, and low pressure water. Do not sand blast the brick because it will destroy the glazing/face of the brick and allow for water to infiltrate into the wall. This will cause structural integrity problems that could lead to entire walls being rebuilt. The awning with the restaurant's name on it is of an appropriate color and size, but a more appropriate awning would not curve downward toward the end. It should be shed-roof-like in design. A major renovation of these east façades could see several changes made to the buildings in order to improve their image. The large, picture window with sidelights on the southern portion of the south building's second-story façade could be made into a shallow arching bow window. The number and configuration of the windows on the old shoe store and the building to the north could be returned to three, evenly-spaced windows. The cornice on the second building should also be maintained and not disposed of. It is one, remaining architectural feature that helps to define the age and character of the building. (Elin Christianson, *Hobart Gazette*, and Hobart Historical Society provided historical information)

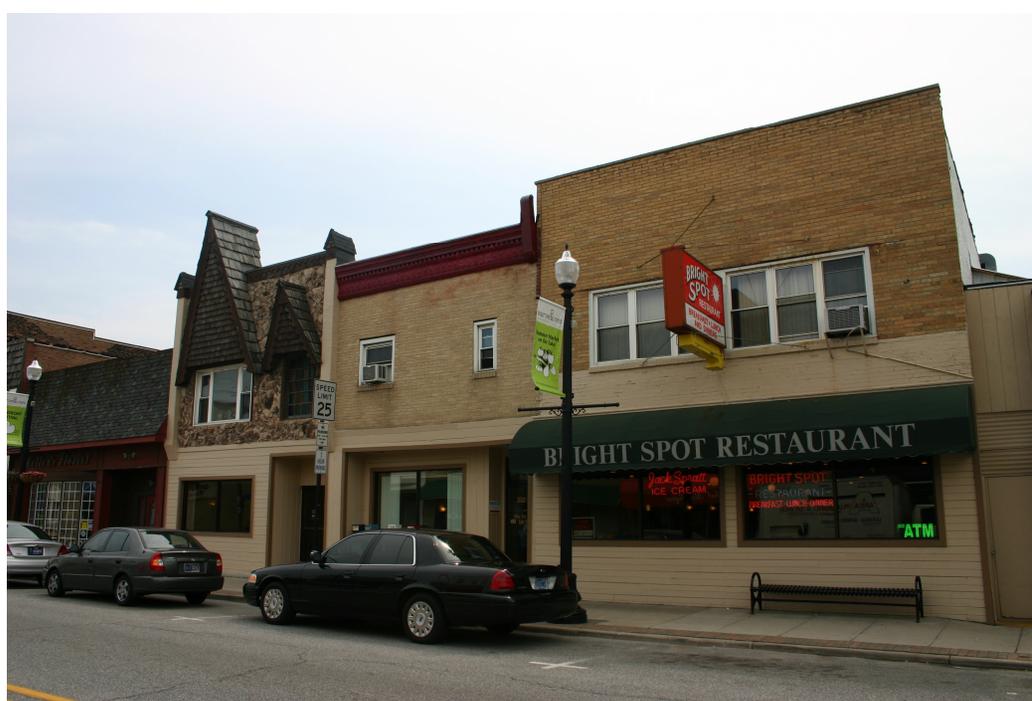
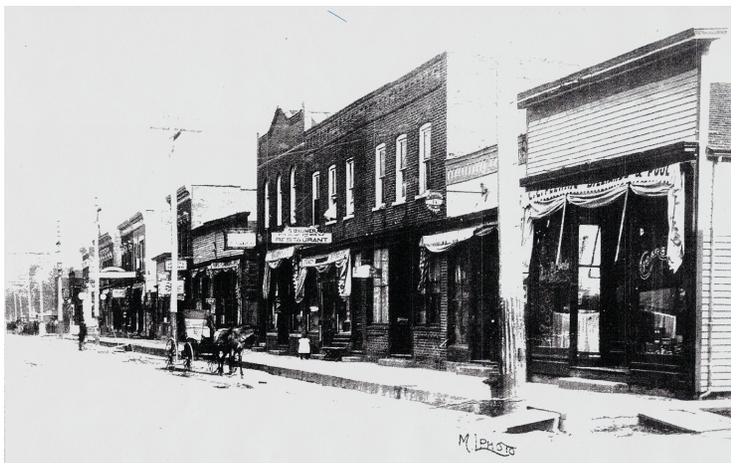
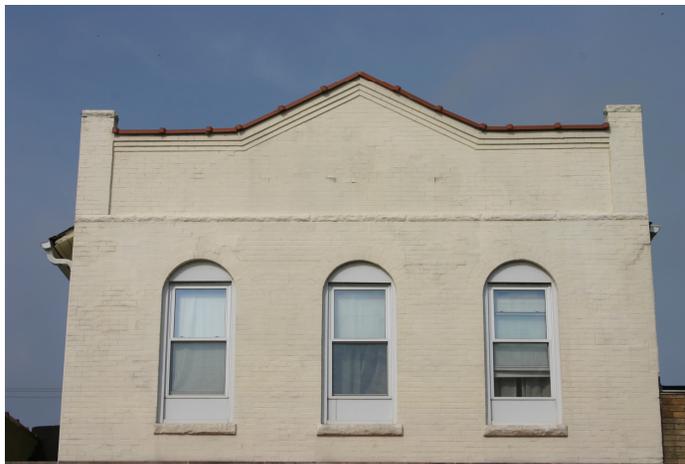
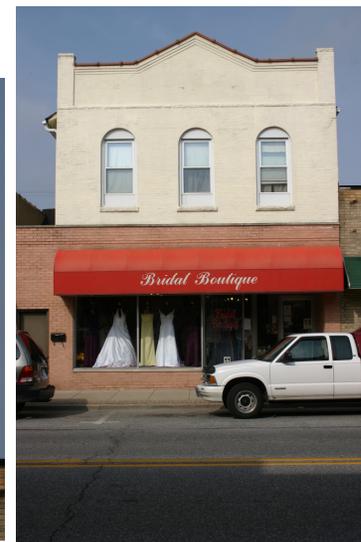
**Butler Building (337 Main):** (Elin Christianson, *Hobart Gazette*, and Hobart Historical Society provided historical information)

The two-story, brick, Butler Building was constructed around 1869 in the Italianate Commercial style. According to notes by Elin Christianson of the Hobart Historical Society, H.C. Tabbert was selling sewing machines, shoes, and monuments in the west (front) storefront space in 1898; he had already been in that location for ten years. Other storefront proprietors were Redding and Ahrens Saloons; Baumer's Bakery; Stevens Bakery & Lunchroom; a pool room; and the Dairy Made Shop. The *1940-41 City Directory* records that the Dairy Made Shop made their own ice cream and candies, and that it had fountain service. The storefront on the west façade has been altered to include four, large, replacement, aluminum, storefront windows across the majority of the building with a single, replacement, aluminum door with transom window above it. This door is located in a recessed entryway on the south side of the façade. Three, evenly-spaced, replacement, vinyl, one-over-one, double-hung windows are located on the upper floor. A small, simple, brick cornice lines the top of the parapet wall along with molded, clay tiles at very top. The building, overall, is in good condition.

**Suggestions:** Change the inappropriate awning to a style that matches with the building to south (shed-roof style awning). The color of the awning is too bold. A darker shade would fit the time period of the building much better. If replacing the second-story windows in the future, replace them windows that fill the entire, historic, window-opening space. Do not remove the original, historic, limestone sills. Carefully remove (use handscraping and mild detergents) the aging paint from the second-story, masonry façade and inspect the condition of the brick. Repair any cracked or missing mortar. If the glazing/face of the brick is damaged or missing, repaint (with historically accurate colors) to prevent water infiltration. If the brick is in good condition, do not repaint.
