# **Historic Downtown Hobart Building Assessment and Rehabilitation Guide**

**Prepared for the Hobart Redevelopment Commission**

**Dean A. Kessler, Ball State University**

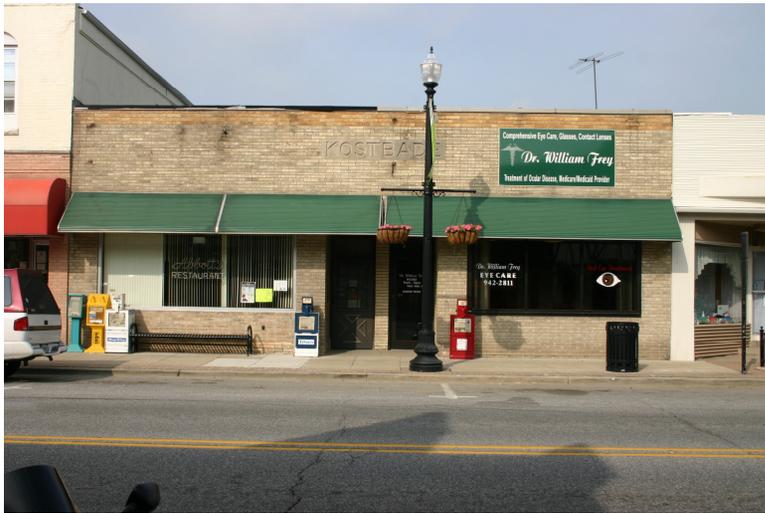
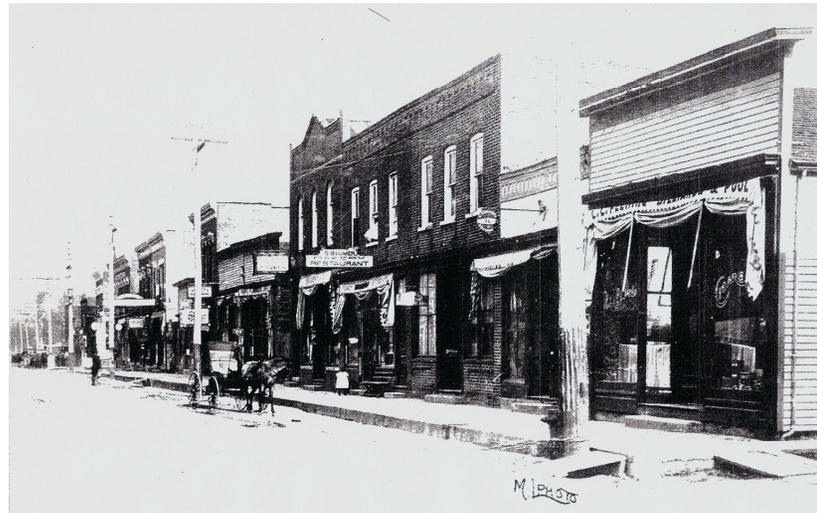
**Kostbade Building (339-341Main):** (Elin Christianson, *Hobart Gazette*, and Hobart Historical Society provided historical information)

The, single-story, **Commercial-Vernacular**, brick, Kostbade building was built around 1930 by Attorney Ray Kostbade. Notes from the Hobart Historical Society suggest that the building was originally built earlier than 1930 and was actually two stories in height (as can be seen the upper, right-hand photo next to 337 Main). Evidence for this claim is hard to find on the building itself, though. It is suggested that it was Kostbade who removed the second story and remodeled the first-story, western, storefront spaces. Nevertheless, this was used as his office well into the 1940s. He also shared the building Fred L. Ruchti who dealt with insurance. Abbott's Restaurant has been a long time tenant as well. The building remains in good condition. The north, 339 side retains the single, 1930s, aluminum, storefront window, while the south, 341 side has three, small, replacement, aluminum, storefront windows. It also appears that the **parapet** wall has been rebuilt at the very top.

**Suggestions:** Give the brick a thorough cleaning using mild detergents, natural-bristle brushes, and low pressure water. Do not sandblast; it will remove the brick's glazing/face and lead to water infiltration. Remove the rusting sign anchors from the parapet wall. Maintain the same style and similar color awning. It is good that the sign for Dr. Fry's office matches the color of the awning and is flush with the building façade. As a note of general maintenance, inspect the parapet wall to make sure it is staying leak-free and not disengaging itself from the face of the building.

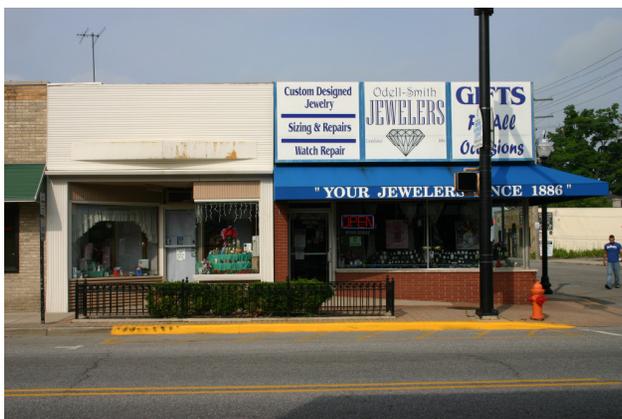
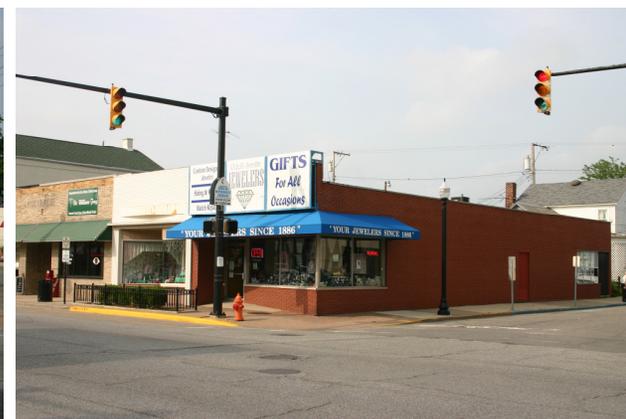
There are two, separate, storefront spaces for O'Dell-Smith Jewelers. Both **Commercial-Vernacular** buildings are brick and a single story. These buildings replaced similar-sized, frame buildings (seen on the very right-hand side of the first photo below) in the late 1950s and early 1960s. The original buildings once housed a harness shop around 1876 and Edgar H. Kleine's pool hall around 1910. The O'Dell-Smith company has been located at this site since 1934. The two, modern, storefronts both contain large, aluminum, storefront windows and modern, aluminum doors with transom windows above them. Aluminum and sheet-metal panels have been added over the original brick on the western (front) façade of 343.

**Suggestions:** Remove the metal panels from the 343 storefront to inspect the condition of the original, brick, façade. If the masonry is in good condition, do not recover the façade. Leave the brick exposed so that it matches the neighboring buildings. If the glazing (faces) of the brick have been damaged or have fallen off, find historically-appropriate material to recover the façade so that structural damage to the wall does not occur. The awning over 347 is an appropriate style for the historic downtown and for the building, but the color does not fit with the historic character of the area. A darker blue, maroon (dark red) or even black could be used on the shed-roof style awning. The **parapet** wall of 347 should also be inspected to make sure that the large signs are not causing it to disengage from the building or cause structural problems. These signs should also be made smaller so that they fit below the top of the parapet wall. They can remain flush

with the building as they currently are. If the masonry needs to be cleaned, use gentle detergents, natural-bristle brushes, and low water pressure. Do not sandblast the brick to clean. This will cause major damage to the brick glazing. If that occurs, water will most likely infiltrate through the wall compromising the structural integrity of that wall.

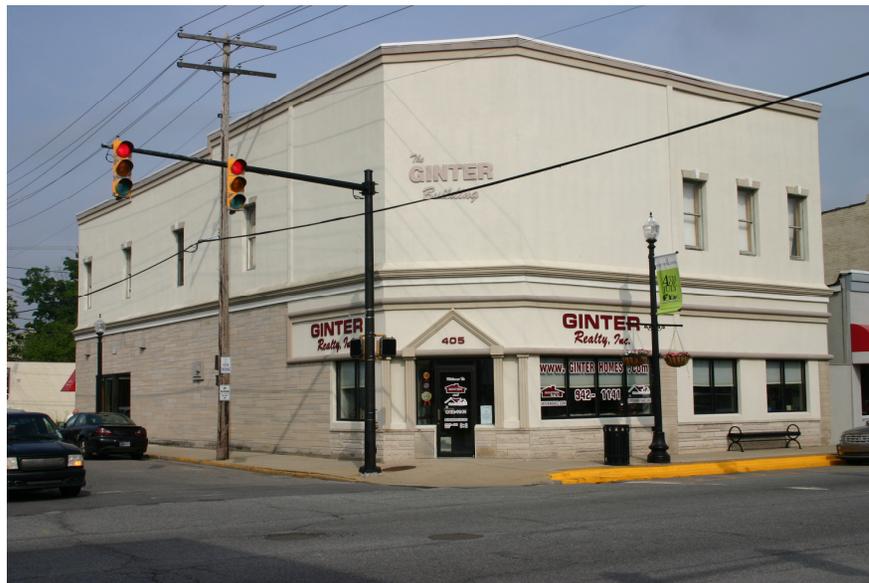
### **Odd Fellows Hall (403-405 Main):**

Currently, the building's north and west, first-story façades are covered in a stone veneer. There are thirteen, large, replacement, aluminum, storefront windows. The main entrance to the first story consists of a single, replacement, aluminum door with sidelights placed on the very northwest corner of the structure. The upper story has been covered over in a material called **EIFS**. Three, original, double-hung, wood, one-over-one windows are located on the southern portion of the west façade, and four, evenly-spaced, windows of the same type are located on the north façade. The signage is of an appropriate size and color for the building. It is good that window hoods have been recreated over the remaining windows, but they do not try to reflect the original window hoods.

**Suggestions:** Remove portions of the stone veneer and EIFS to investigate whether the original, brick façade exists and is in good condition. If the original façade is in good condition, remove the rest of the stone and EIFS and make repairs (tuck-pointing/cleaning) to the masonry as needed. If the brick façade is severely damaged and cannot be repaired without rebuilding the brick walls, the current façade can be reapplied. If a possibility, though, brick façades should be given back to the building. The current façade is inappropriate for the age and original usage of the building. Maintain the original windows that are still left. Do not replace these historic, character-defining features. Try to recreate or replicated the original windows if documentation exists on how they were designed. The signage may stay the same. (Elin Christianson, *Hobart Gazette*, and Hobart Historical Society provided historical information)

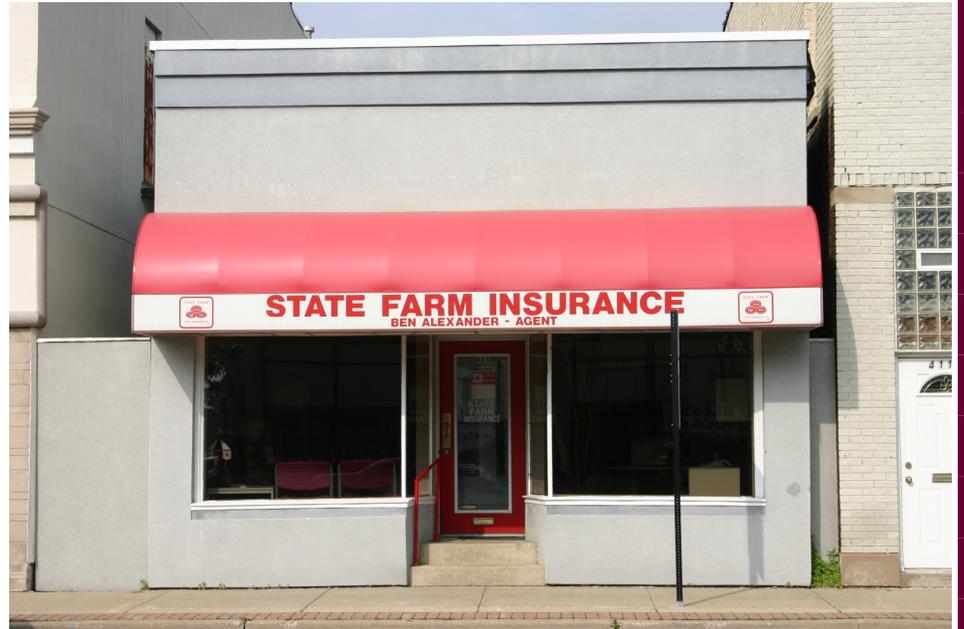
### **409 Main:**

The west, storefront, façade still contains the 1928, wooden door that is flanked by the four, large, 1928, aluminum, storefront windows. The original, wood-sided façade (seen on the next page to the left of the Cartensen building) has been covered over in **EIFS**. Pressed, sheet-metal lines the top of the **parapet** wall.

**Suggestions:** Maintain the storefront configuration and original, 1928 materials. Do not replace these historic, character-defining features. Remove a portion of the EIFS on the front façade to discover if the original, wood, clapboard siding still exists. If the clapboard still exists, remove the rest of the EIFS to expose this façade. Make repairs to the wood as necessary and paint it to prevent water infiltration. If the original façade does not exist or is poor condition, restore the original, wood-sided façade by replacing the missing or damaged boards with new wood. The inappropriate awning should also be changed to a shed-roof style awning. This type of awning does not curve downward, away from the front of the building. It comes down off of the building in a shallow slope. The color of the awning should remain bright red. A darker, more historically-accurate color should be chosen. Dark blues, greens, maroons, and even black are more appropriate. As a rule of general maintenance, investigate the condition of the parapet wall to make sure that water is not entering through any spaces between the roof and the wall. Be sure to check that the wall is not disengaging itself from the rest of the building.

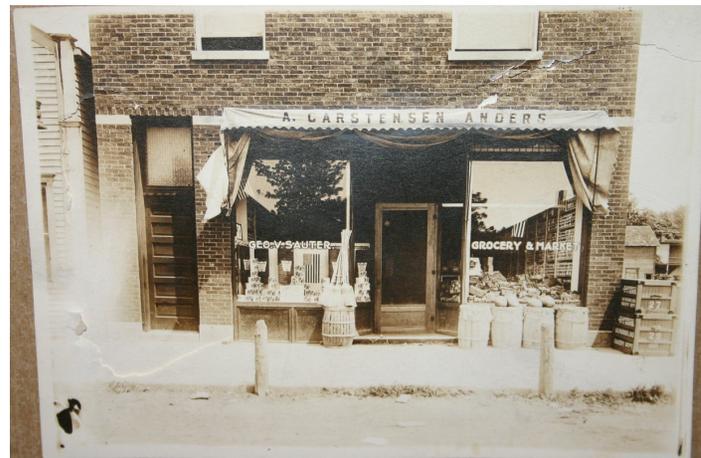
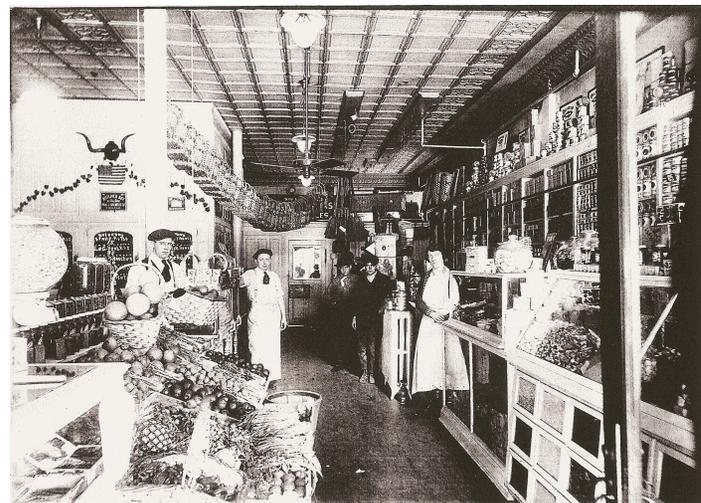
### **Carstensen Building (413 Main):**

The building currently retains the same configuration of its main, west, first-story storefront. The storefront windows have been replaced with modern, aluminum windows, and the door, while wood, is also a replacement. A brick veneer was added underneath the replacement, storefront, windows. The transom windows above the door and storefront windows are original. A replacement, paneled, steel door with replacement, glass-block transom window is located to the north of the storefront and has access to the second story. Three, replacement, glass-block windows are located on the south façade. Eight, original, wood, one-over-one, double-hung windows with modern, aluminum, storm windows are located on the second-story west and south façades. Two, original, wood, single-paned windows are also located on the south façade. The original, brick, **cornice** and dentils at the top of the original, **parapet** wall and original, brick, dentil belt-coursing above the storefront also exist. It appears that the parapet wall with limestone headers above the original cornice is an addition that was added at an unknown, later date. The brick was laid without the same patterns that can be found on the west and south façades. It also appears that this same addition was repaired or rebuilt at some point since it is not painted like the rest of the west façade and second story on the south façade.

### **Suggestions for Carstensen Building:**

Retain the current configuration of the storefront and do not replace the original, transom windows. Do not replace the original windows on the second story. Maintain these windows and keep them in working order. They are character-defining features to the building. Carefully remove the non-original paint from the west and south façades by lightly handscraping off the paint. This will help to bring the building back to its original, unified look. Then, gently wash all of the brick surfaces using mild detergents, natural-bristle scrub brushes, and low pressure water. Do not sandblast the brick as this will take off the glazing/face of the brick and allow for water infiltration into the wall. Water infiltration will cause harm to the structural integrity of the wall. Make sure to repair any cracked or missing mortar. Use a good lime mortar, not concrete to tuck point. Concrete will not allow the bricks to breath or expand and contract. Only if the brick faces are damaged or missing is it recommended that the entire building be repainted to prevent water infiltration. The signage on the building is good as is. It is not too large a size for the main façade and is appropriately fixed flush with the exterior wall. The colors and font do not detract from the building. If replacing the glass-block windows in the future, find single-paned windows to fill their places.

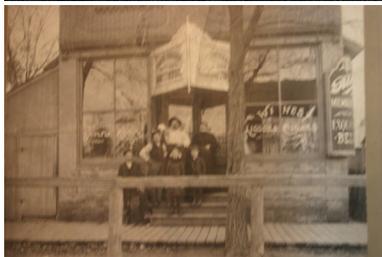
**517 E 3rd:** (Elin Christianson, *Hobart Gazette*, and Hobart Historical Society provided historical information)

This, two-story, brick, **Italianate Commercial**, building was built in 1890 and used first as Hillman's Saloon or, "The Hub," and later operated by Henry Ittel. In the 1920s Bob Wheaton owned an electrical shop there. After that, it again became a saloon and pool hall; a dance school; and a nursery school. It has been a karate school since the early 1970s. Several years ago a fire heavily damaged the building. All of the 15, second-story windows are replacement, vinyl, double-hung, one-over-one windows. The **window hoods** over the three windows on the main, north façade were recreated using **EIFS**. The main, north, storefront consists of six, small, replacement, aluminum, storefront windows that flank a single, central, replacement, aluminum door. To the west of the storefront is a single, replacement, steel door with access to the upper floor. The original limestone at the top of the north **parapet** wall and the limestone window sills exist. The other three parapet walls have pressed, sheet-metal at the top.

**Suggestions:** Remove peeling paint. Then, gently wash all of the brick surfaces using mild detergents, natural-bristle scrub brushes, and low pressure water. Do not sandblast the brick as this will take off the glazing/face of the brick and allow for water infiltration into the wall. Water infiltration will cause harm to the structural integrity of the wall. Make sure to repair any cracked or missing mortar. Use a good lime mortar, not concrete to tuck point. Concrete will not allow the bricks to breath or expand and contract. Only if the brick faces are damaged or missing is it recommended that the entire building be repainted to prevent water infiltration. There are visible examples of damaged brick face throughout the exterior. Most likely the building will need to be repainted. It is also recommended that the signage be reduced in size and number. The large sign that says, "KARATE," is inappropriate and should be removed. The sign that is flush with the building below it is more appropriate and could stay. The painted advertising on the east façade should also be reduced in size. It is too large for the building. Try to reopen the windows and doorways that have been bricked-in on the first story of the east façade as well. Reopening those windows will help to restore the building to its original look and feel. Reopen the entire, original, window space of the west window on the upper, north façade. Try to expose the original brick of the north storefront to help unify the north façade.

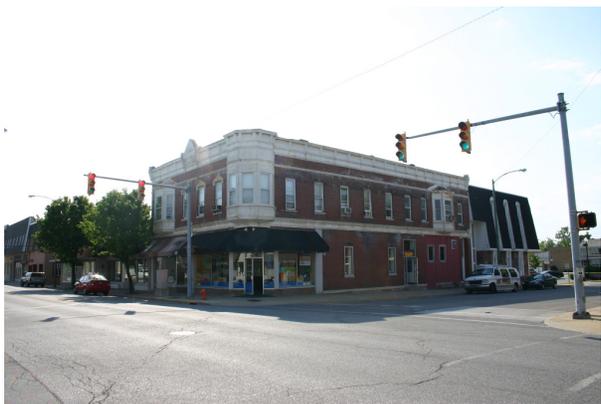
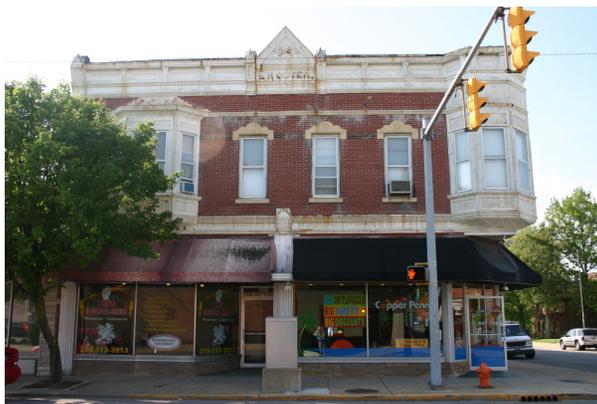
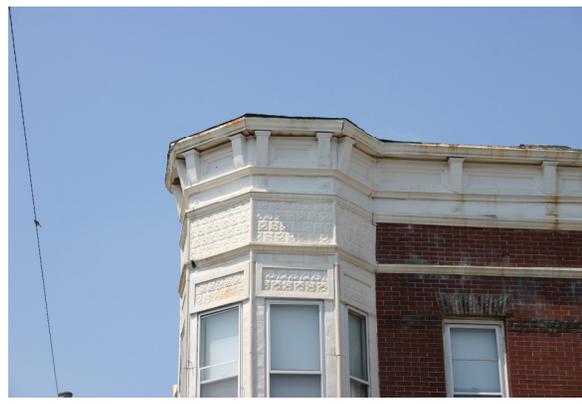
The condition of the decorative, pressed, sheet-metal is getting to be in poor condition. Paint is peeling off of it and there are many rust stains running down the detailing. The brick is showing signs of water infiltration. A white powder called efflorescence can be seen below the cornice and belt-coursing. Efflorescence is caused when

the minerals within the brick and mortar that have been deposited as the moisture evaporates out of the masonry wall. If this issue is not solved, structural damage could occur as a result of the infiltration of water. The awning on both storefront spaces are also faded, stretched, and torn.

**Suggestions:** Efflorescence can be easily cleaned, but it will return if the water is not stopped from entering the wall. This general maintenance issue can be solved by investigating the seals between the roof and the **parapet** wall; the windows and the brick; and between the belt-coursing and the brick. Be sure to repair any leaks in the roofing and make sure that parapet is stable and not disengaging itself from the building. Check the seams between the sheet-metal as well. The rest of the brick should be gently cleaned using mild detergents, natural-bristle scrub brushes, and low pressure water. Do not sandblast the brick as this will take off the glazing/face of the brick and allow for water infiltration into the wall. Make sure to repair any cracked or missing mortar. Use a good lime mortar, not concrete to tuck point. Concrete will not allow the bricks to breath or expand and contract. Do not paint the brick. Also, keep the same configuration of the storefronts. Carefully remove the peeling paint from the sheet-metal surfaces; repair the rusting portions and replace any missing/broken detailing; and repaint the sheet-metal to continue its protection from water and other elements. Do not remove the pressed, sheet-metal detailing; it is an important, historic element to the building. Continue to maintain and protect the original, wood windows. Do not remove these historic features. Replace the worn awnings with new awnings of in-kind material and design. Choose one color for both awnings to have so that the storefront spaces and entire building remain unified in look and feel. Signage may be placed on the awnings, in the storefront windows, or flush against the building. Be sure that the signage is not too large or historically inappropriate. If placed on the building itself, be sure not to cover any of the character-defining features. The inappropriately-designed extension of the building at **220 Center** needs to have the peeling paint on its wooden surfaces removed, and then it needs to be repainted. If possible, remove the mansard-style roof and build a brick wall that will continue on the same plane as the original building. Use brick that will be similar in color to the 1897 masonry.

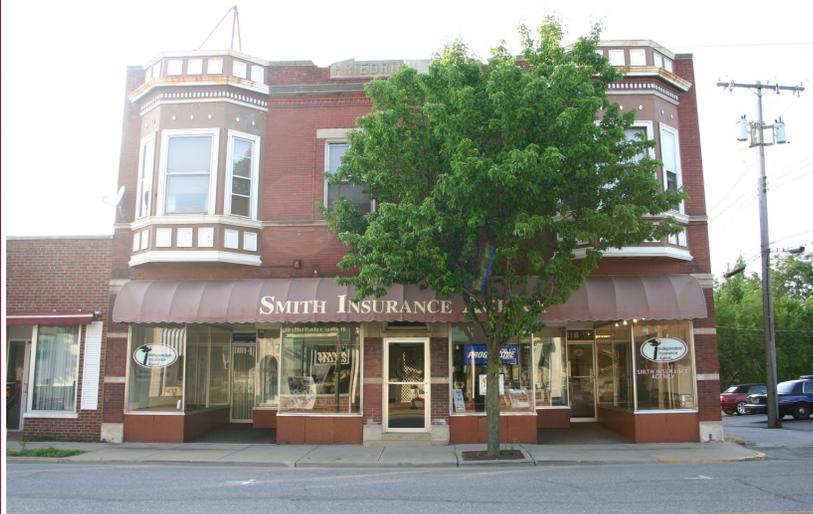
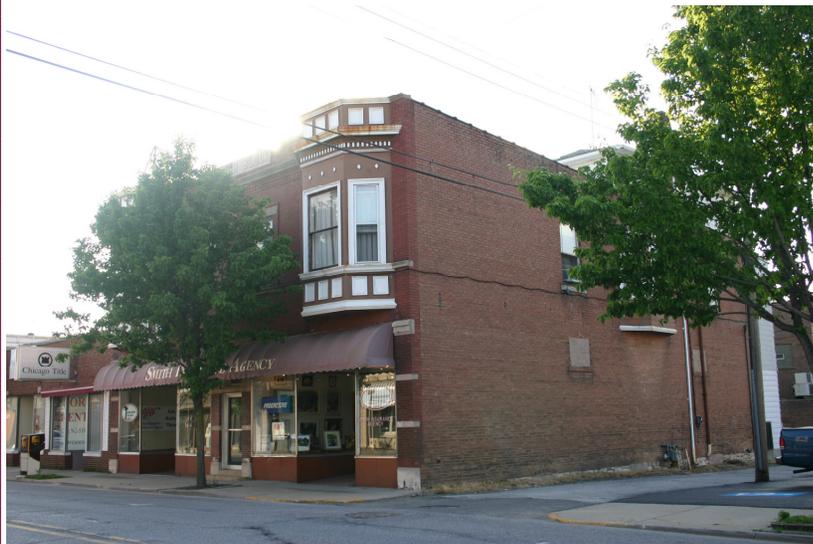
### **The Friedrich Block (614-618 E 3rd):**

Like its neighbor across the street, the Friedrich Block retains quite a few of its original, architectural features on its main (southern) façade. The poured-concrete **belt-coursing** and inlays; pressed, sheet-metal window bays and detailing; a portion of the poured-concrete **date block**; brick **dentils** at the top of the second story (between the bays and under the belt-coursing); and the original, one-over-one, double-hung, wooden windows all remain. The actual date on the date block is missing. The storefronts at 614 and 618 have been reconfigured and now contain six, large, replacement, aluminum windows and a single, replacement, aluminum door with transom window above it. Metal panels were added below the newer

windows along the sidewalk and entries. Access to the second-story living spaces is through a single, replacement, aluminum and glass door located in the center of the south façade, between the two storefronts.

**Suggestions:** Retain all historic features mentioned on the previous page. Do not replace the original windows. Carefully restore and repair these historic, character-defining features. Maintain and keep all decorative, pressed, sheet-metal detailing/**cornices** painted and free from rust or deterioration. These metal features need to be gently stripped of the paint, treated to rid them of the rust, and then repainted for protection against the elements. The brick on all of the building should be gently cleaned using mild detergents, natural-bristle scrub brushes, and low pressure water. Do not sandblast the brick as this will take off the glazing/face of the brick and allow for water infiltration into the wall. Make sure to repair any cracked or missing mortar. Use a good lime mortar, not concrete to tuck point. Concrete will not allow the bricks to breath or expand and contract. Do not paint the brick unless the brick faces have already fallen off or are starting to deteriorate. The paint will help prevent water infiltration. As a rule of general maintenance, be sure to repair any leaks in the roofing and make sure that parapet walls are stable and not disengaging themselves from the building or allowing water to infiltrate the interiors of the exterior walls. The street tree should also be cut back so that it does damage the brick faces with its branches.

Try to repair the date block by reconstructing the date feature (based on the historic photographs) and attaching it to what remains. The awning that is currently on the building is of an appropriate color, but not of an appropriate size or shape. The awning should be divided into two separate awnings over each, individual storefront. A more appropriate shape for the awning would be a shed-roof style awning like the Guyer Block has or the 1910 Wild Building across the street. An awning for this building should have a low/shallow pitch. Be mindful as to the text on the awning. It should reflect the 1910 era of the property. By separating the awnings, a space will be left open over the entrance to the second-story apartments so that the decorative, poured-concrete, **pediment** above the door can be easily seen. It is a major, character defining feature to the first-story façade, but it cannot be seen with the current awning that has been placed over it.

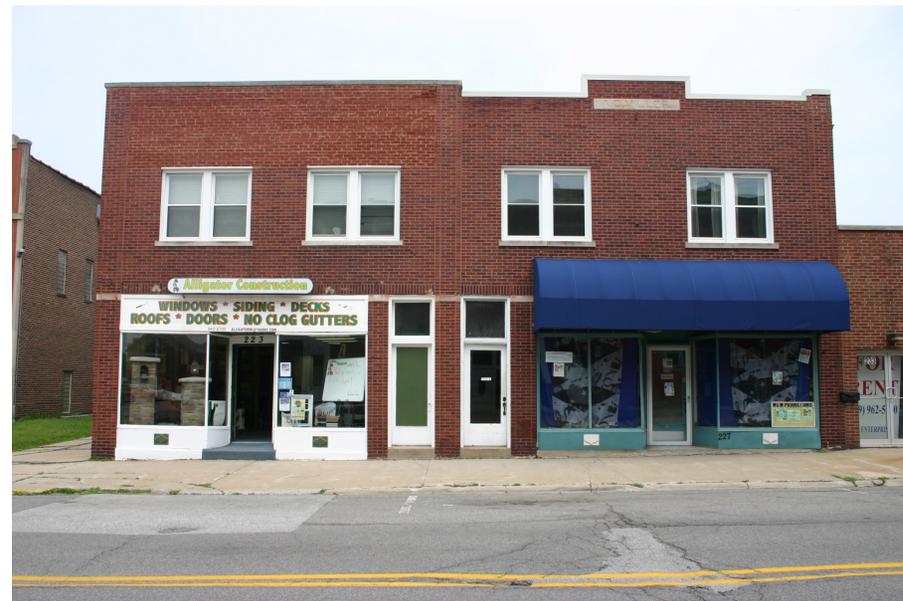
### **A.G. Miller Buildings (223-227 Center):**

The north and south storefront façades remain relatively unchanged. They still contain their large, original, aluminum windows and wooden doors. The original, wooden door to the north of 227's storefront is access to the second-story apartments. The original, wooden door to the north of that has access to the mechanical systems on the first floor of 223. Most of the windows (except for four) throughout the 1926 and 1929 buildings have been replaced with vinyl, double-hung, one-over-one windows. The apartment over the garage on the east portion of the property still retains its original, wood, double-hung, one-over-one windows.

**Suggestions:** The brick on all of the building should be gently cleaned using mild detergents, natural-bristle scrub brushes, and low pressure water. Do not sandblast the brick as this will take off the glazing/face of the brick and allow for water infiltration into the wall. Make sure to repair any cracked or missing mortar. Use a good lime mortar, not concrete to tuck point. Concrete will not allow the bricks to breath or expand and contract. As a rule of general maintenance, be sure to repair any leaks in the roofing and make sure that **parapet** walls are stable and not disengaging themselves from the building or allowing water to infiltrate the interiors of the exterior walls. Also, keep the same configuration of the storefronts. Do not replace original windows or doors of the storefronts. If possible, do not replace the original, character-defining windows of the apartment over the garage. Remove the rusted grounds from previous signage on the west façades. The blue awning over 227 is too large and historically inaccurate. Remove this awning and do not replace it with a new one. Signage for this storefront should follow the example set at 223. It should be flush with the building and of an appropriate size.

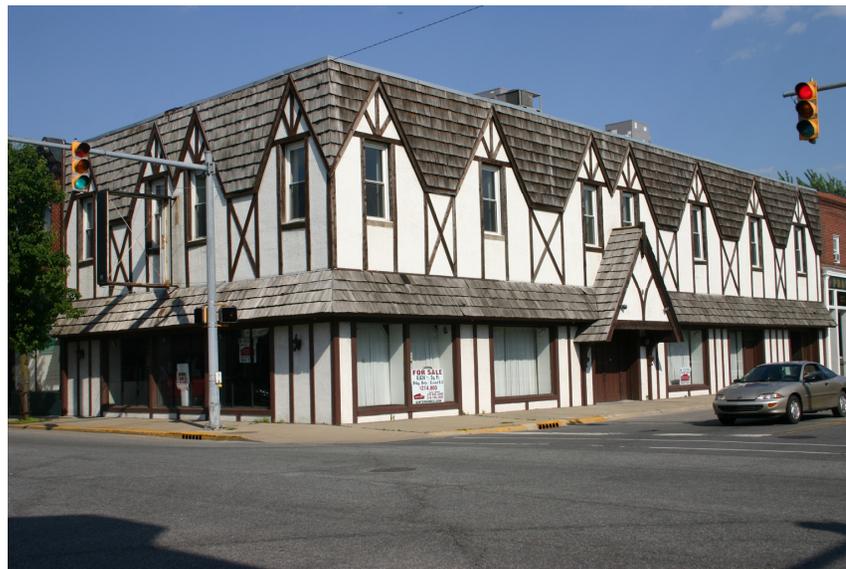
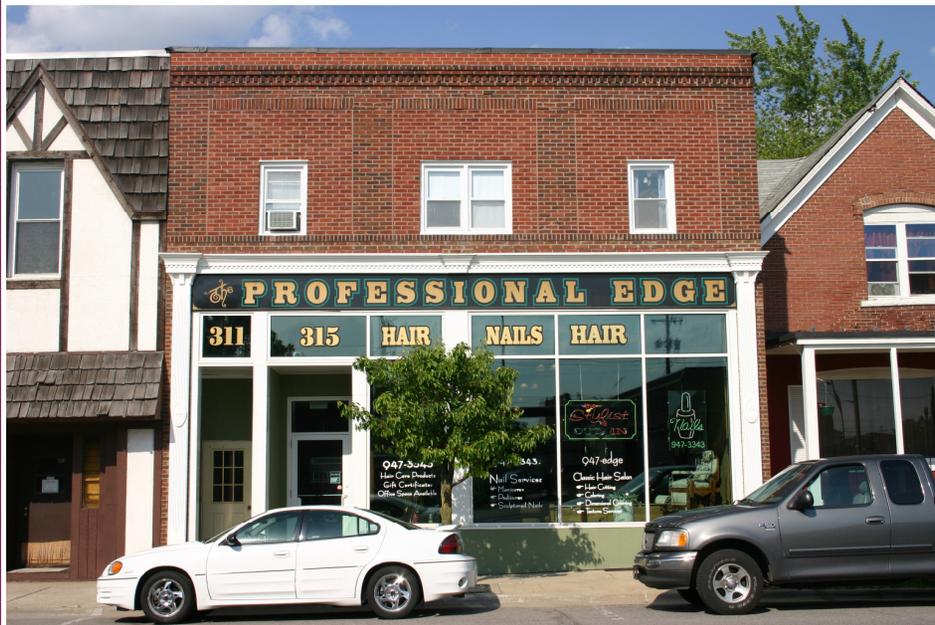
**311-315 Center:** (Elin Christianson, *Hobart Gazette*, and Hobart Historical Society provided historical information)

This two-story, Commercial Vernacular, brick and clay tile building was built around 1914 by Paul Newman. According to Elin Christianson’s — president of the Hobart Historical Society — notes, Newman used the tile to build a fireproof garage on the back of his hardware store. The building was also used as a residence on the second story. It has housed Wheaton Appliance and Hobart Beauty College as well. The building has been well maintained and is appropriately restored. The main, western, façade, storefront windows are replacements and made from vinyl. The five, second-story, vinyl, one-over-one, double-hung windows are also replacements. They are also smaller than the original windows as can be seen by the brick infill around them. The original, brick **cornice** and **parapet** wall still exist. The signage on the windows and sign board compliment the historic character and age of the building well.

**Suggestions:** If replacing the second-story windows in the future, replace them with larger windows that will fill the original openings of the original windows. The brick on all of the building should be gently cleaned using mild detergents, natural-bristle scrub brushes, and low pressure water. Do not sandblast the brick as this will take off the glazing/face of the brick and allow for water infiltration into the wall. Make sure to repair any cracked or missing mortar. Use a good lime mortar, not concrete to tuck point. Concrete will not allow the bricks to breath or expand and contract. Do not paint the brick unless the brick faces have already fallen off or are starting to deteriorate. The paint will help prevent water infiltration. As a rule of general maintenance, be sure to repair any leaks in the roofing and make sure that parapet walls are stable and not disengaging themselves from the building or allowing water to infiltrate the interiors of the exterior walls. Do not change or reconfigure the storefront. If installing new signs in the future, follow the precedent already set.
